MINISTRY OF TRANSPORTATION
DIRECTORATE GENERAL OF CIVIL AVIATION

RESPONSE

BULLETIN

ISSUE 02 | JULY 2019

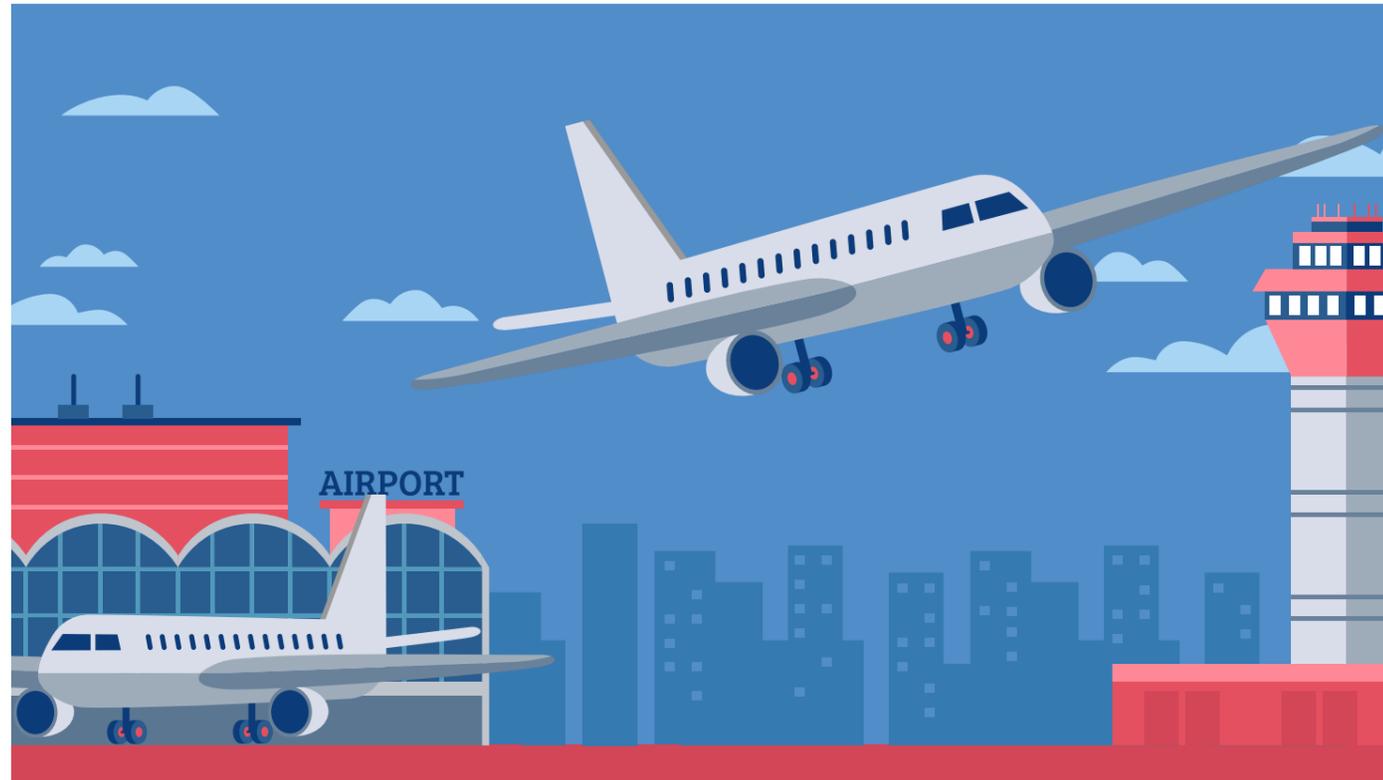
01. Late Runway Change from 03 to 13 Without Any Info

A reporter reported late runway change information from 03 to 13 from the ATC. The arriving aircraft using ILS runway 13 by radar vector. Then landed at runway 13 after clearance obtained. Actual landed time 00.18 UTC. After all stopping devices deployed and aircraft

reach taxi speed, suddenly they saw a departing aircraft just airborne on top of them using runway 03.

It is necessary to ensure a good coordination procedure among ATC units, particularly the information of runway change

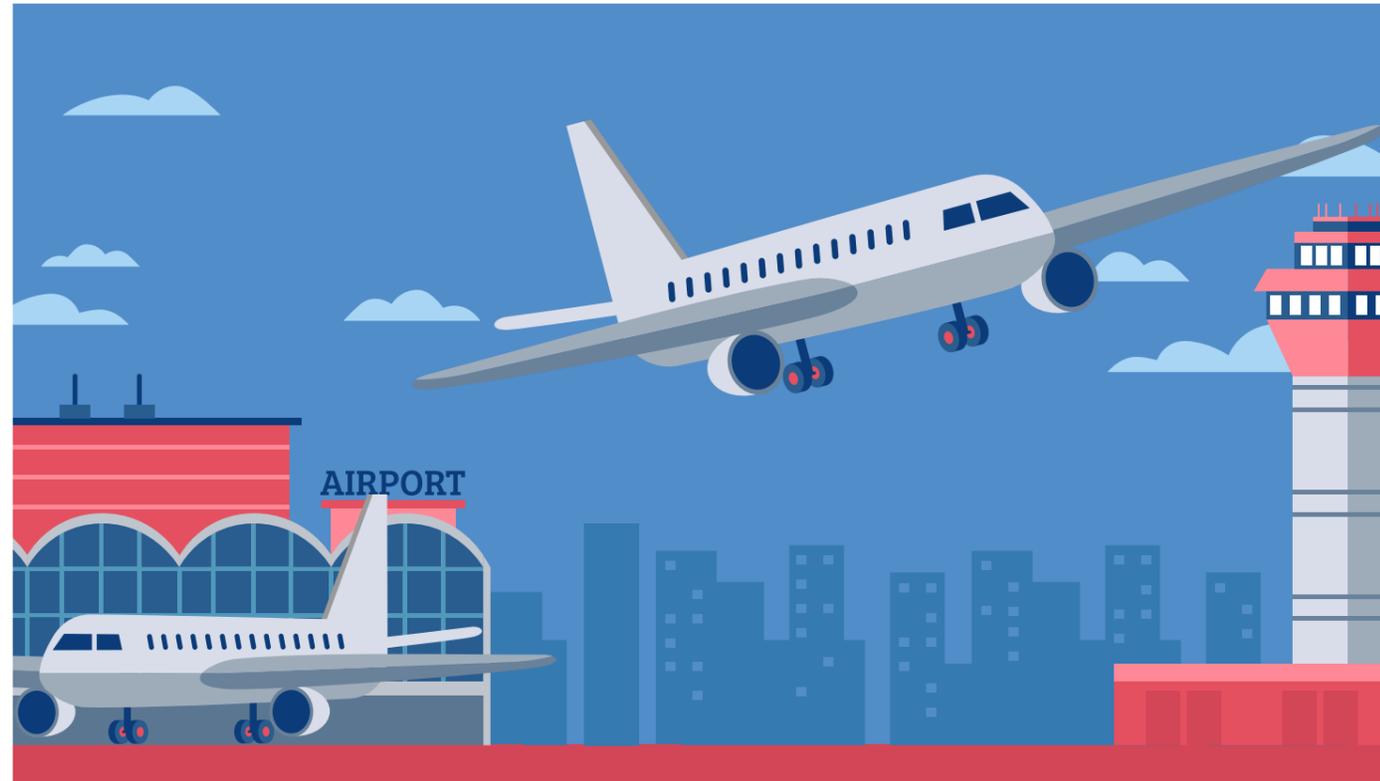
02. Miscommunication with ATC

During climb, the ATC told the reporter “climb to FL310”. The radio quality reads was now and then at that time, and what they heard was climb to FL350 and do READBACK clearly to “climb FL350” for 2 times, and asking confirmation to maintain final level 350, just for make sure. There was no correction or negative statements. Then after

they reached FL350, control told that they supposed to climb FL310. They had a bit arguing about what they readback and what they said, so then they tried to apologize, and descent to FL310 all the way to Kota Kinabalu. The rest was normal operation and landed safely.

It is necessary to ensure a good coordination procedure among ATC units, particularly the information of runway change

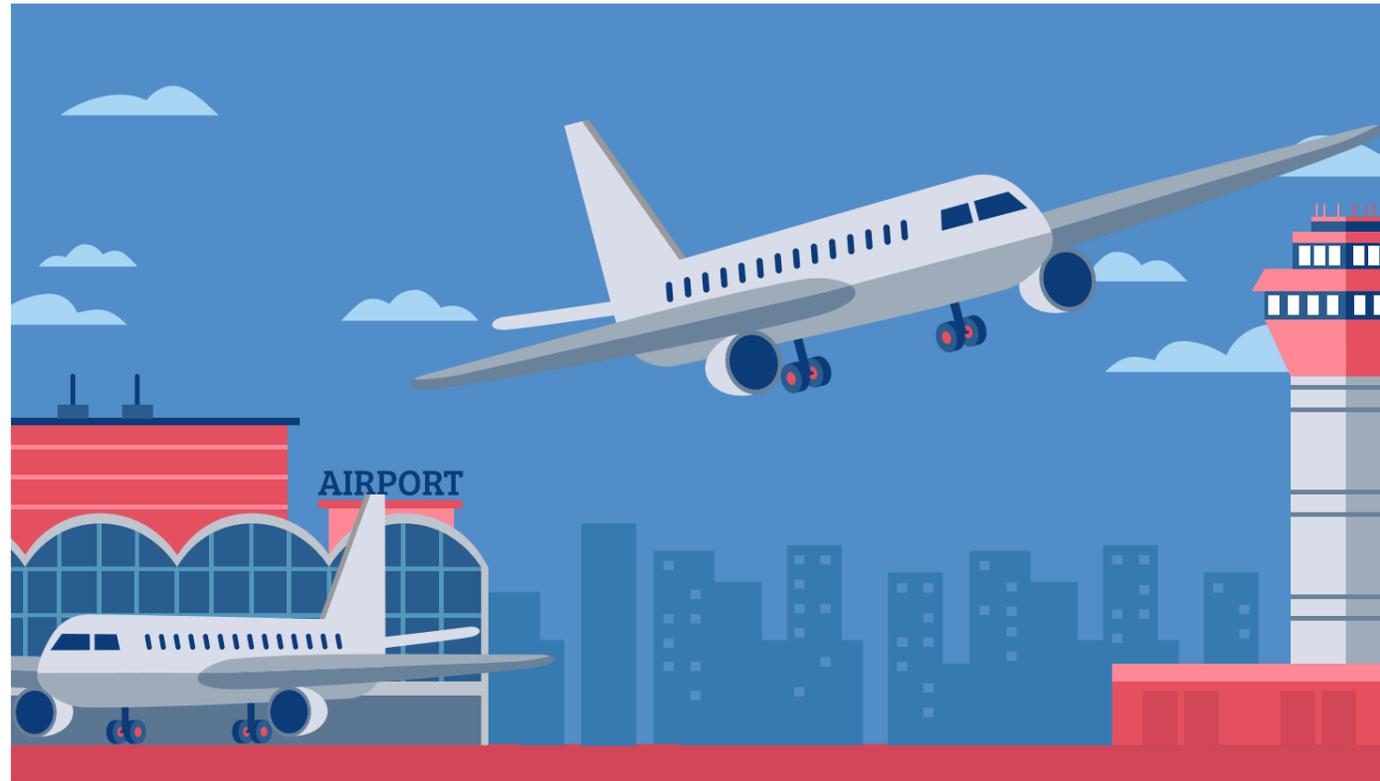
03. Miscommunication with ATC

After landing runway 32, the tower gave them clearance to 180 degrees turn present position, exit runway via taxiway B. Readback with confirmation, still taxiway B. They passed the taxiway A, and saw one aircraft holding at taxiway B. They confirmed to tower, and then gave them instruction to make 180 degree turn and taxi exit

runway via A taxiway.

It is essential for the ATC personnel to expedite and maintain an orderly flow of air traffic

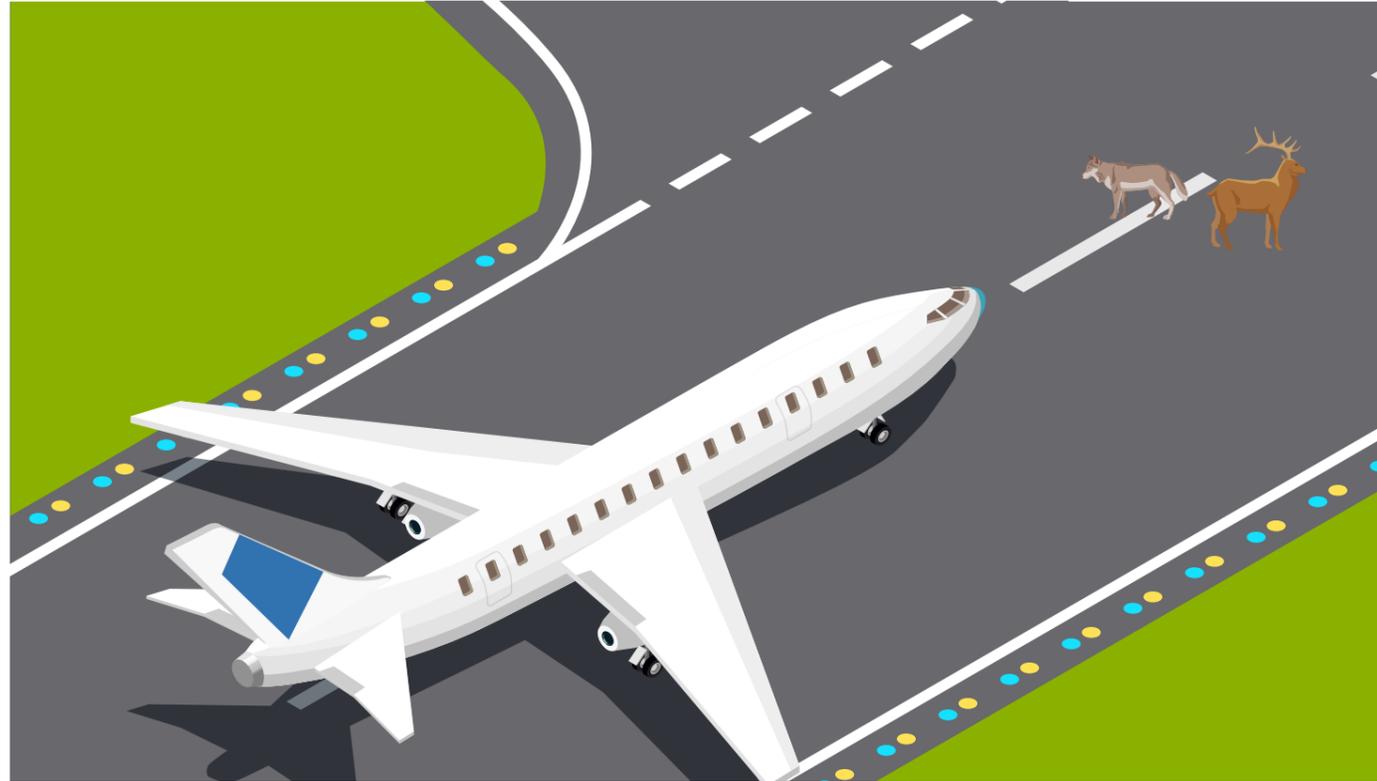
04. Animal on Runway

ATC informed there was an animal on runway. The pilot made decision to go around, made another approach and landed safely.

This case has been occurred frequently. It is important for every airport to ensure the wildlife hazard surveillance is conducted properly in accordance with wildlife hazard management manual.

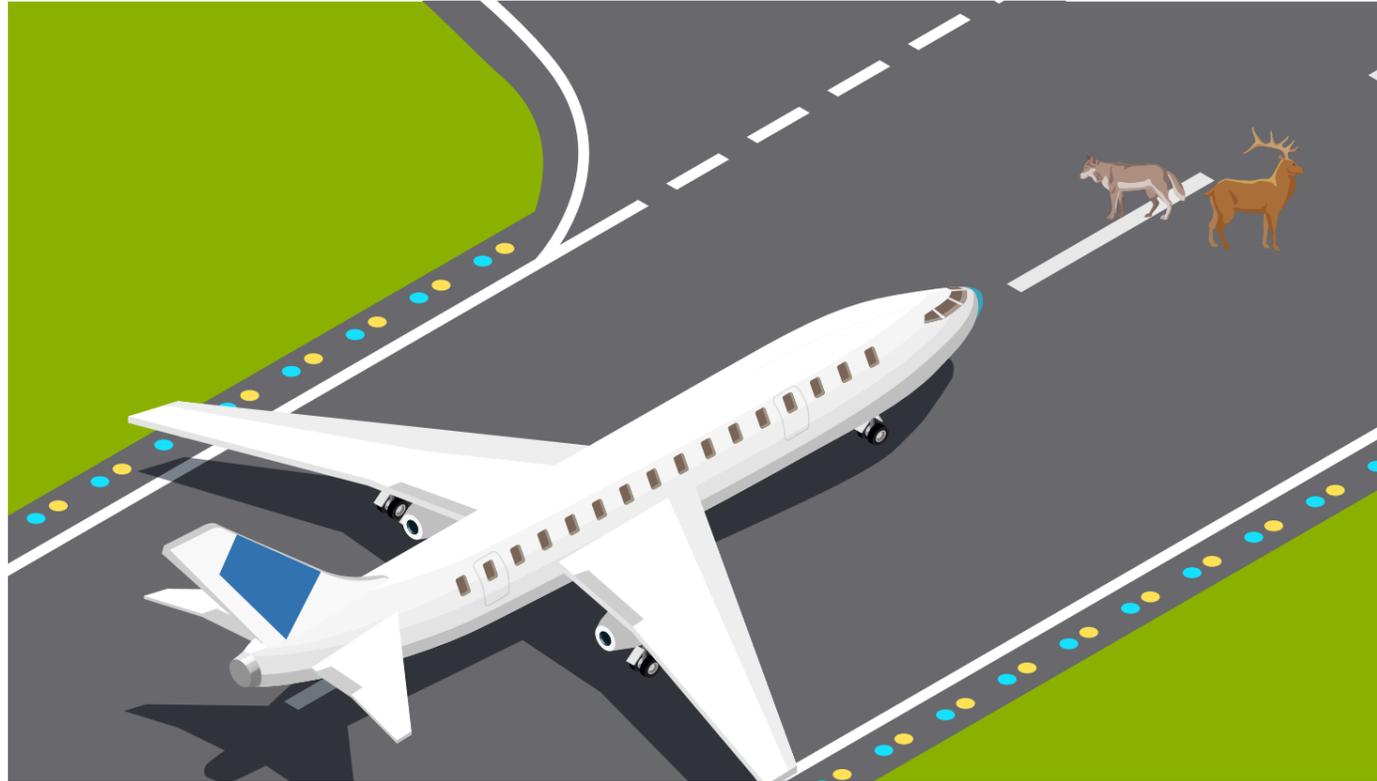
05. Animal on Runway

Informed by ATC there was animal on runway, Pilot made 360 (holding on final)

This case has been occurred frequently. It is important for every airport to ensure the wildlife hazard surveillance is conducted properly in accordance with wildlife hazard management manual.

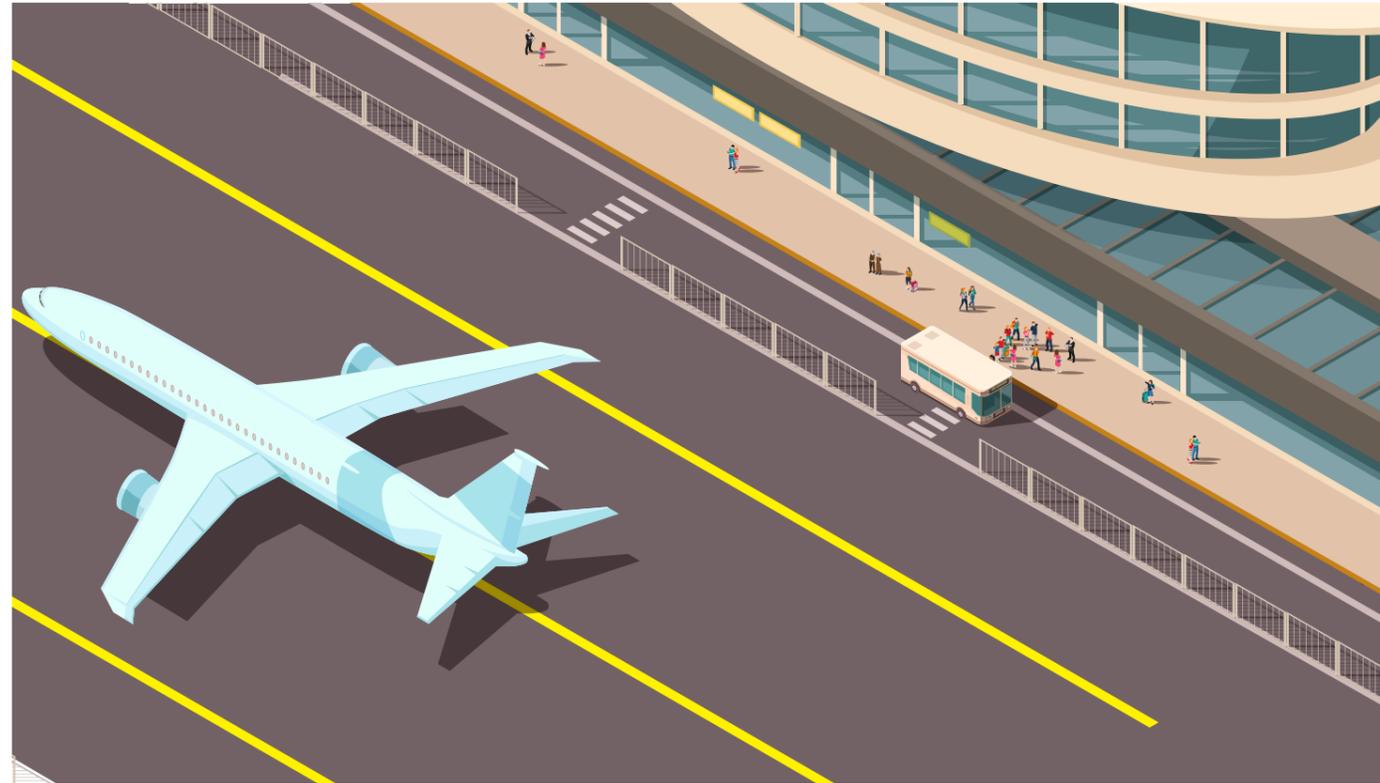
06. Required Higher Thrust During Taxi (soft taxiway surface)

During taxi on Short taxiway H, aircraft cannot move until 40% thrust

It is important for aviation personnel to report the airside area condition to the airport operator if they found any abnormal condition. Based on that, it is essential for the airport operator to increase the awareness when receiving these kind of reports and take immediate action to fix the problem.

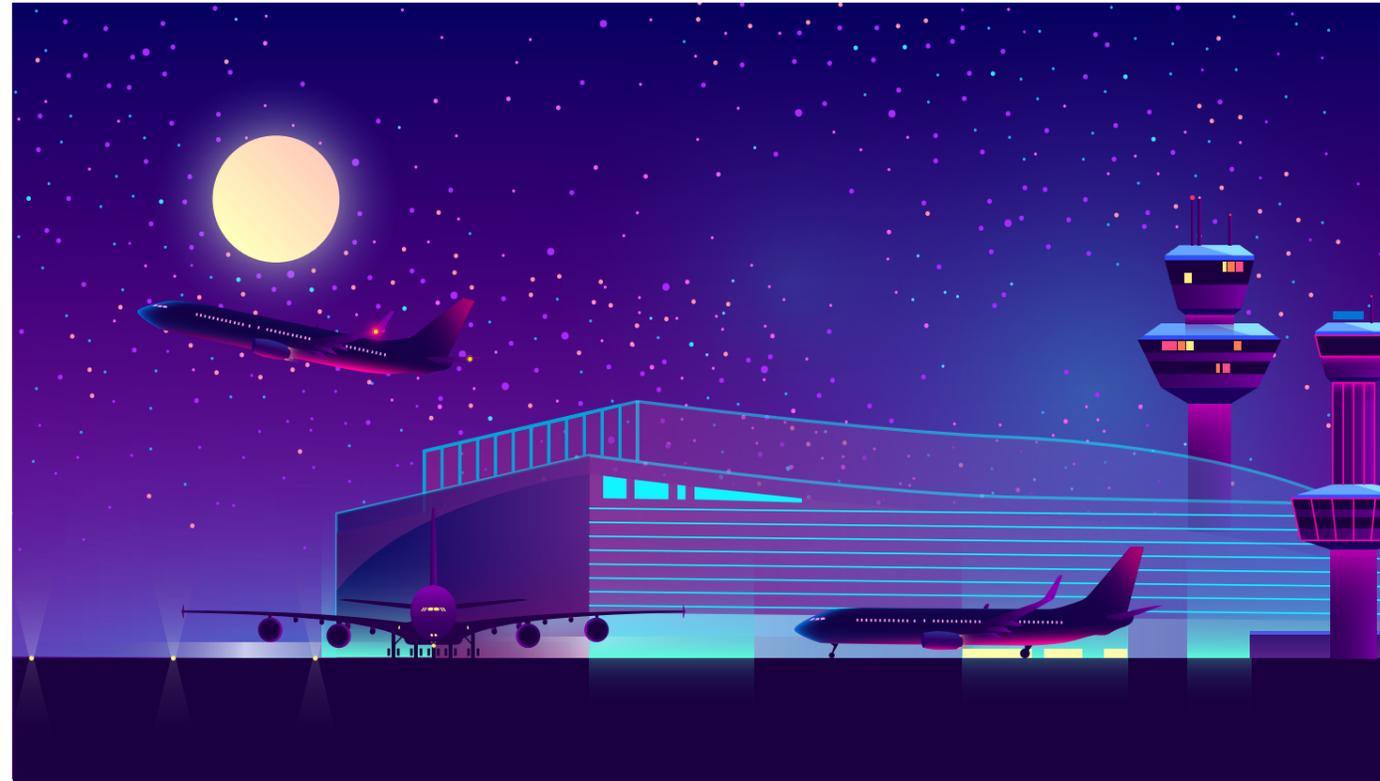
07. RTB Due to bad weather

PIC received information from radio operator at XX airport that weather was heavy rain, visibility 2 km, ceiling 30 feet and getting worst. PIC decided RTB

This case must be a good decision making. It is necessary for a pilot to make decision that an aircraft should not land at a below minima weather condition.

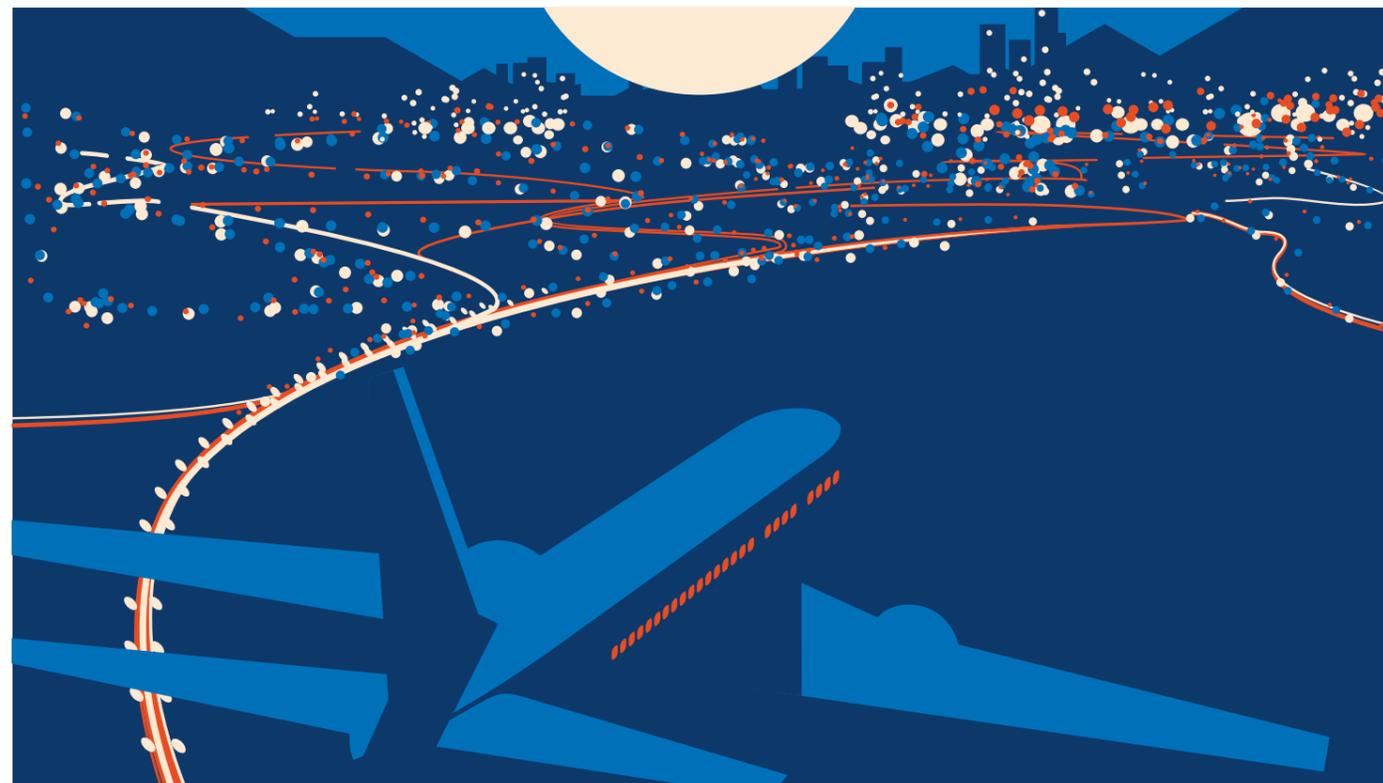
08. Unreliable ILS Guidance

Unreliable ILS Guidance upon establishment ILS runway 10 after leaving point, ILS guidance became unreliable. Resulting the aircraft moving abruptly. PIC as PF disengaged the autopilot and flew the aircraft manually to maintain proper flight path.

Thank you for reporting. It is important for aviation personnel to report any ILS abruption to the air navigation service provider (ANSP). Based on that, the ANSP may take action to inspect the condition and conduct mitigation.

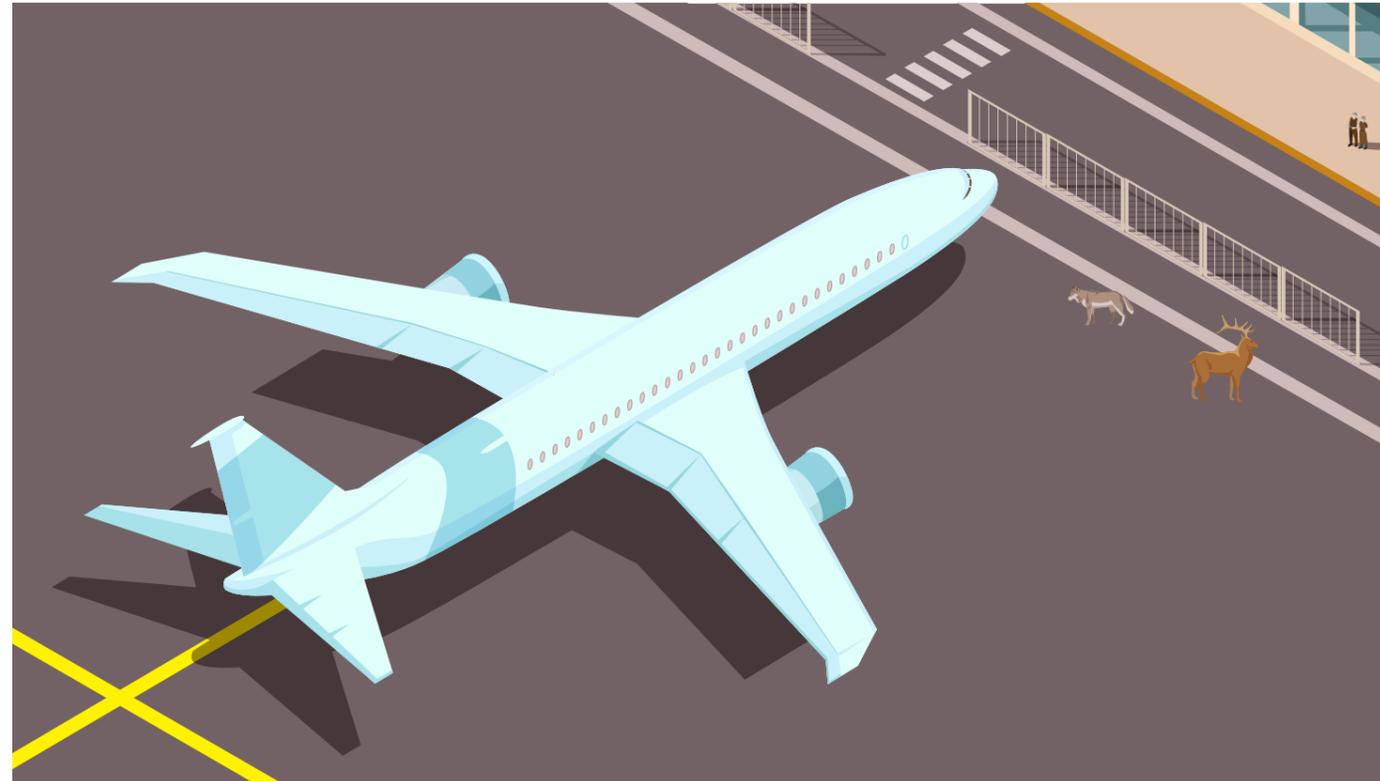
09. Animal Present on Apron

When an aircraft prepare for flight, there is a dog that appears at the apron and then successfully secured by Avsec. We have reported this to the airport manager. This is the third report on wildlife animals in this airport.

This case has been occurred frequently. It is important for every airport to ensure the wildlife hazard surveillance is conducted properly in accordance with wildlife hazard management manual.

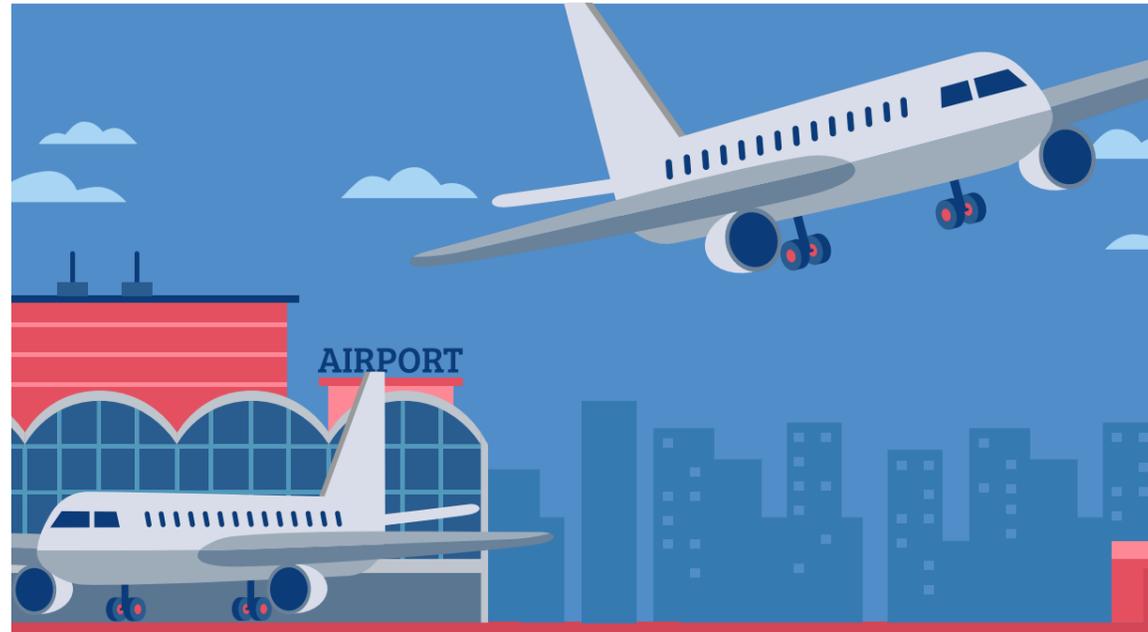
10. Miscommunication with ATC

Approaching XXX airport due to NOTAM on ILS RW36, flight crew prepared RNAV approach RW36. During descent, passing FL220 cleared descent to 2500', direct "point A" by XXX APP. Approaching "point A", XXX APP gave clearance, "Aircraft A" CLEARED FOR ILS RW36". Then flight crew confirmed to XXX APP "Confirm Aircraft A Cleared for ILS?" (it means ILS is fully serviceable). XXX APP said "affirmed, Aircraft A cleared for ILS APP RW36" then flight crew prepared landing ILS

RW36. Established on Localizer ILS RW36, found that G/S was not came out. Flight crew confirmed to YYY Tower, and they said "Glide Slope still U/S". Then flight crew try to make NPA Localizer Approach, but it was unable to perform. Then decided Go Around proceed to "point A" and preparing for RNAV Approach RW 36. After cleared for approach, did RNAV Approach RW36 and safe landing at XXX airport.

Thankyouforthereport.Inorder to deliver accurate information to pilot during approach and landing, it is essential for an ATC to understand the condition of the airport facilities in NOTAM condition and deliver the information to the pilot completely.

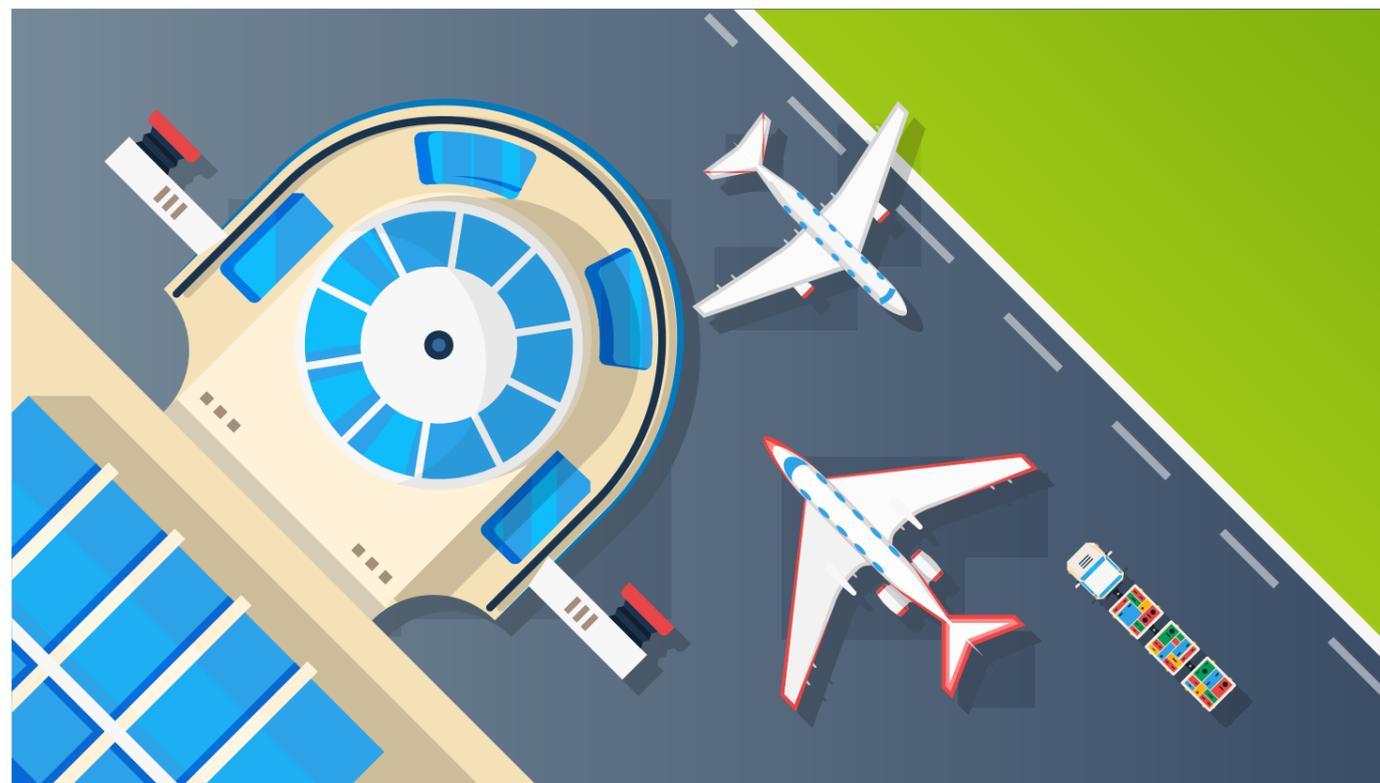
11. Near Collision in Ground

After landing on runway XXX, Aircraft A was instructed to expedite exit via N4. Ground instructed to continue via NP2 and NCY. There was traffic Aircraft B on NP2 taxiing to holding point N9 runway XXX. Aircraft B was approaching N4 and did not stop. Aircraft A stopped before NP2. After passing, confirm to ATC and report it.

Thank you for sharing. It is important for a pilot to monitor another aircraft which is moving near. It is also important for a ATC to expedite and maintain an orderly flow of air traffic.

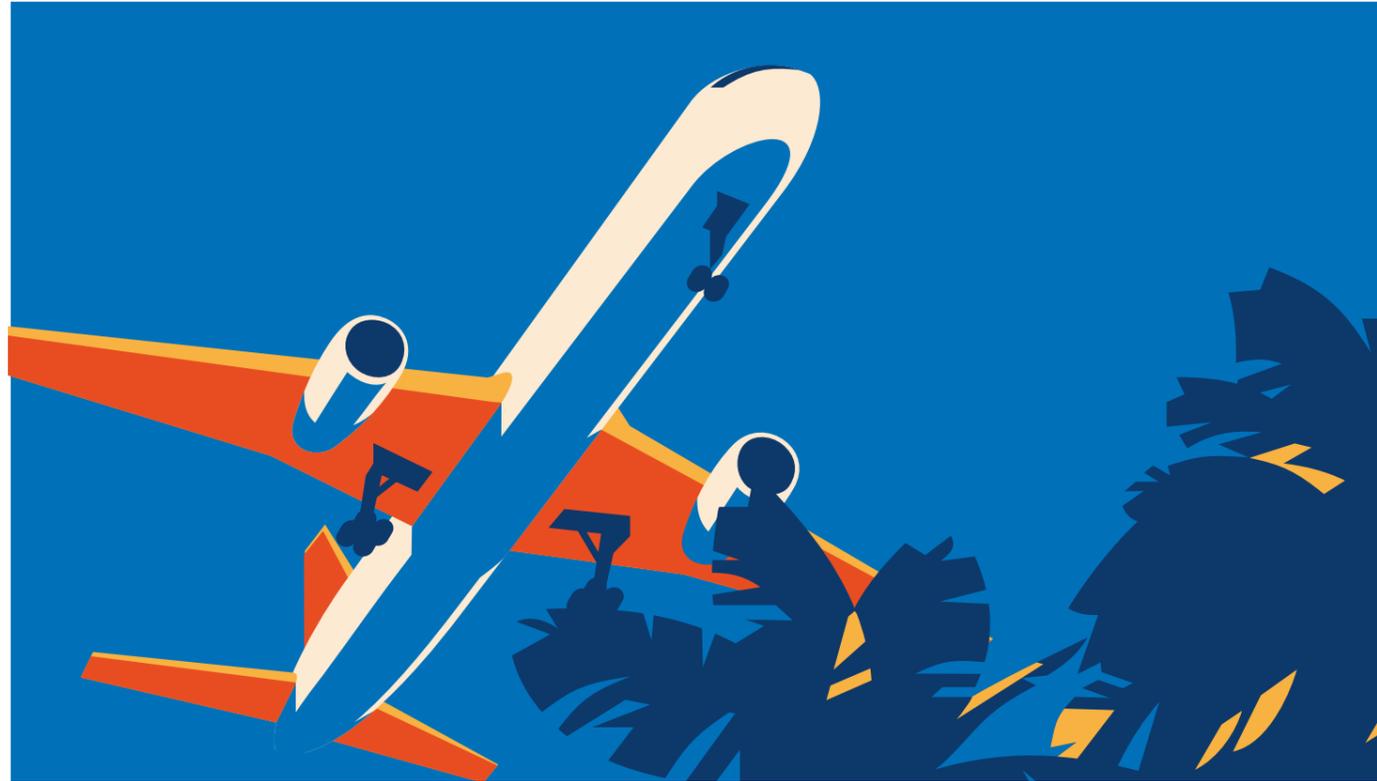
12. NAV AIDS not available

No instrument approach procedure, as company gives chart just only for guidance. Waypoints latitude and longitude are quite accurate. - When follow “yoyo” the descent path is shallow than expected. At approximately 2-3 nm to touchdown we fly full visually in order to adjust height over hill that present around 2 nm final, then continue recapture normal glidepath to runway 04

at short final. - During listening watch in tower (122.4) since sometimes the frequency mixed with nearest traffic airport frequency.

In order to confirm the condition of frequency, it is essential to inform the condition of mixup frequency to ANSP first. After that, ANSP can check the condition and take appropriate action.

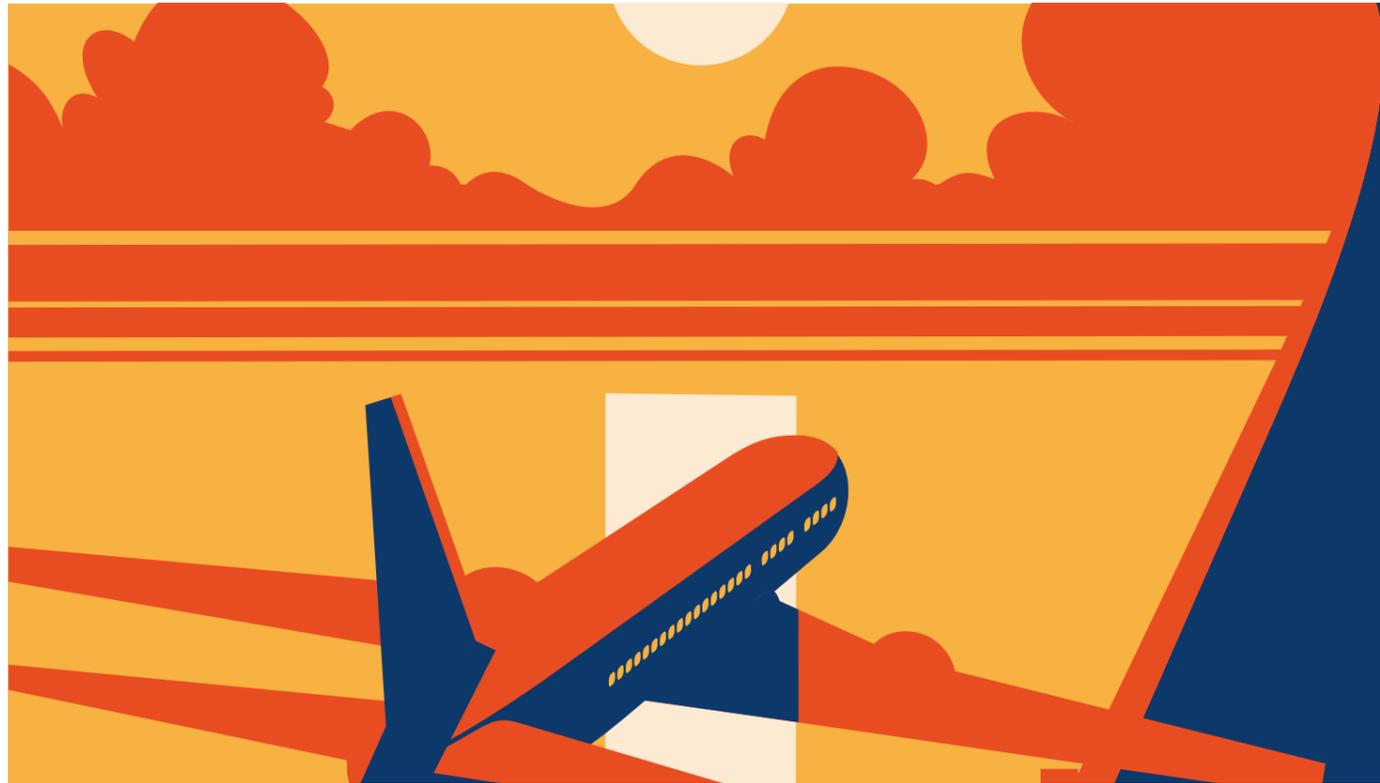
13. Divert due to bad weather

“Take off from Airport A to Airport B, position 5NM to Airport B info from Airport B afis that weather at Airport B heavy rain and visibility 800m. PIC decided to divert at Airport C for safety reason. The aircraft safely landed at Airport C 07:40 UTC. at 07:43 UTC info from Airport B afis visibility at Airport B 5km, The aircraft Take off from Airport C 07:45

Utc and landing Airport B at 07:55 UTC “

This case is an example of a good decision making. It is necessary for a pilot to make decision that an aircraft should not land at a below minima weather condition.

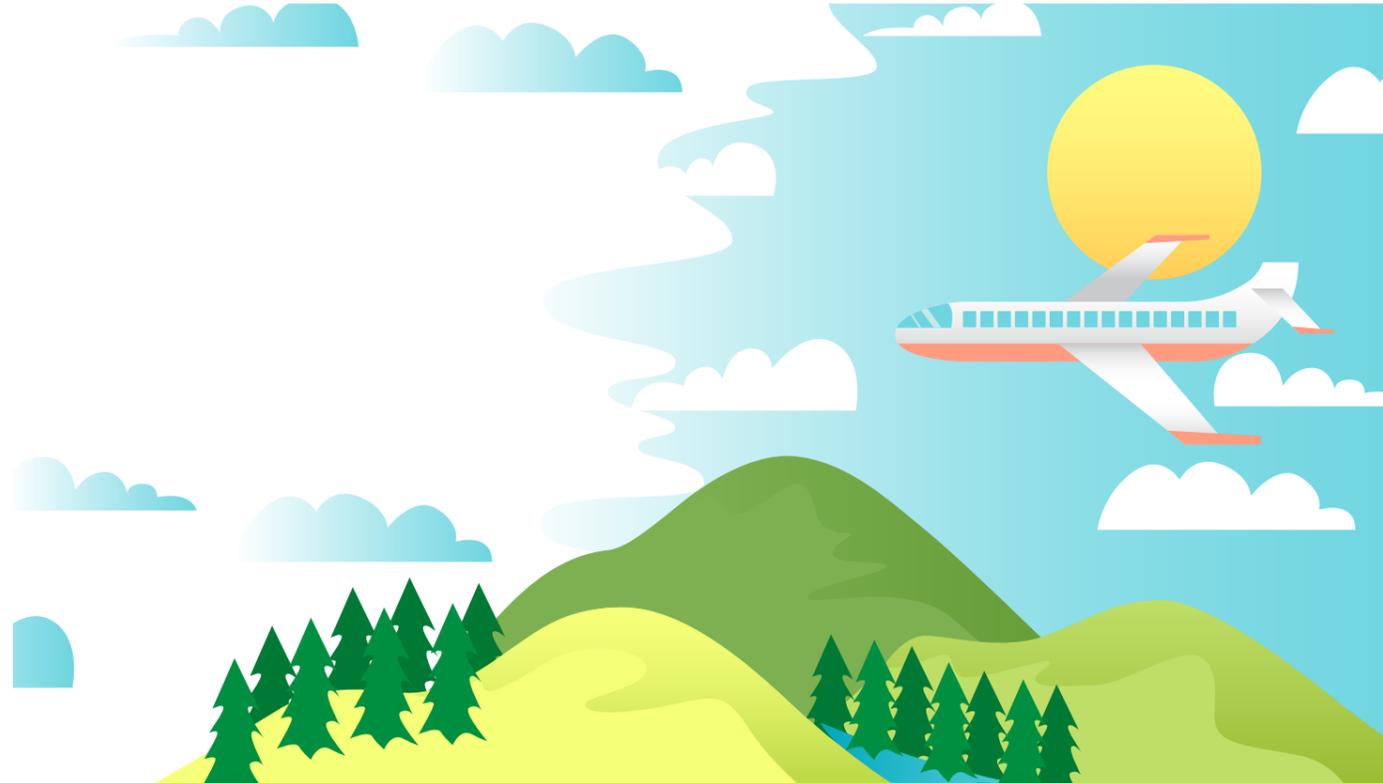
14. Terrain at final runway

There is terrain at final runway XXX is very close - The parking number stand & latitude / longitude is too small so its not seen from aircraft

In order to confirm the condition of terrain and parking stand, we recommend it is necessary to ask confirmation of the condition to the airport operator together first. And it is also important for them to discuss the result of confirmation and solution of issue if necessary together.

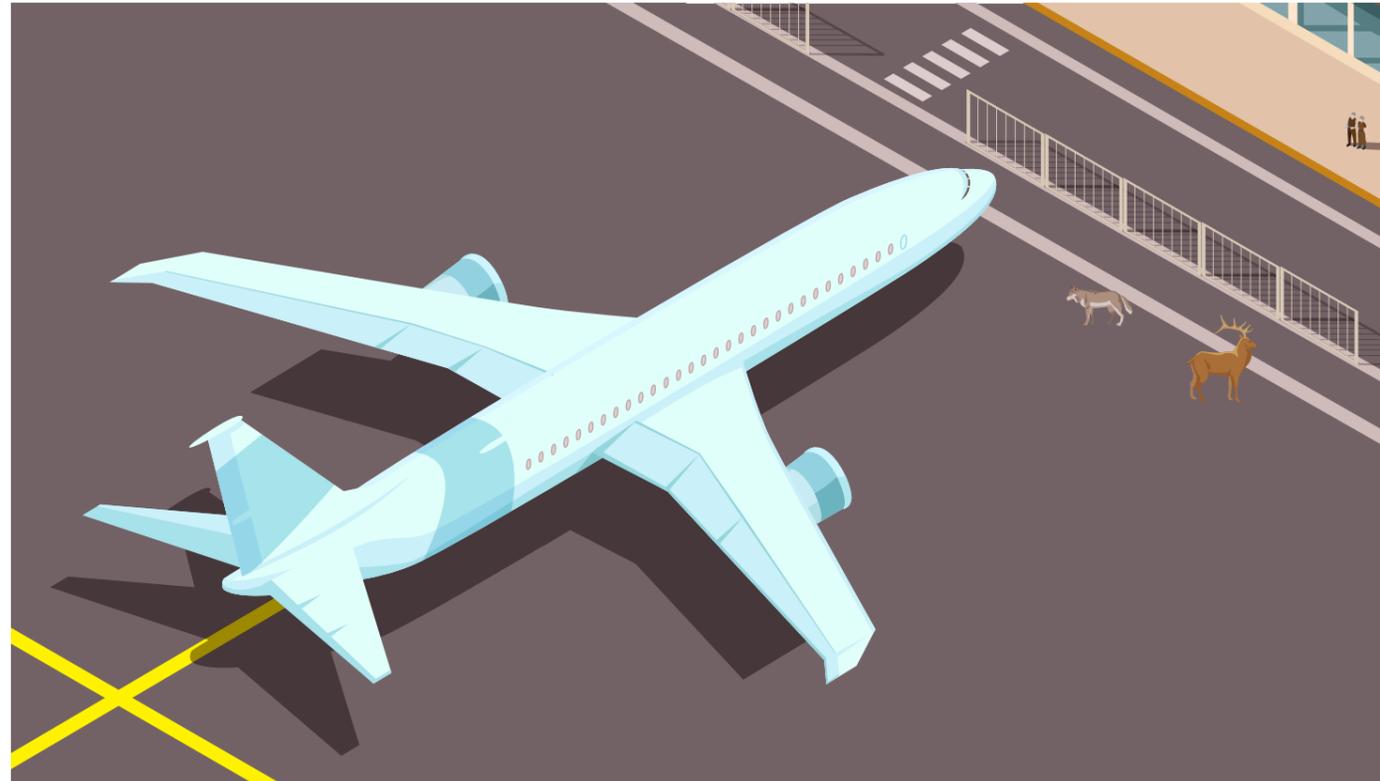
15. There are dogs around apron

Seen a black dog running around the apron, which can lead to fatal and disrupted operational.

This case has been occurred frequently. It is important for every airport to ensure the wildlife hazard surveillance is conducted properly in accordance with wildlife hazard management manual.

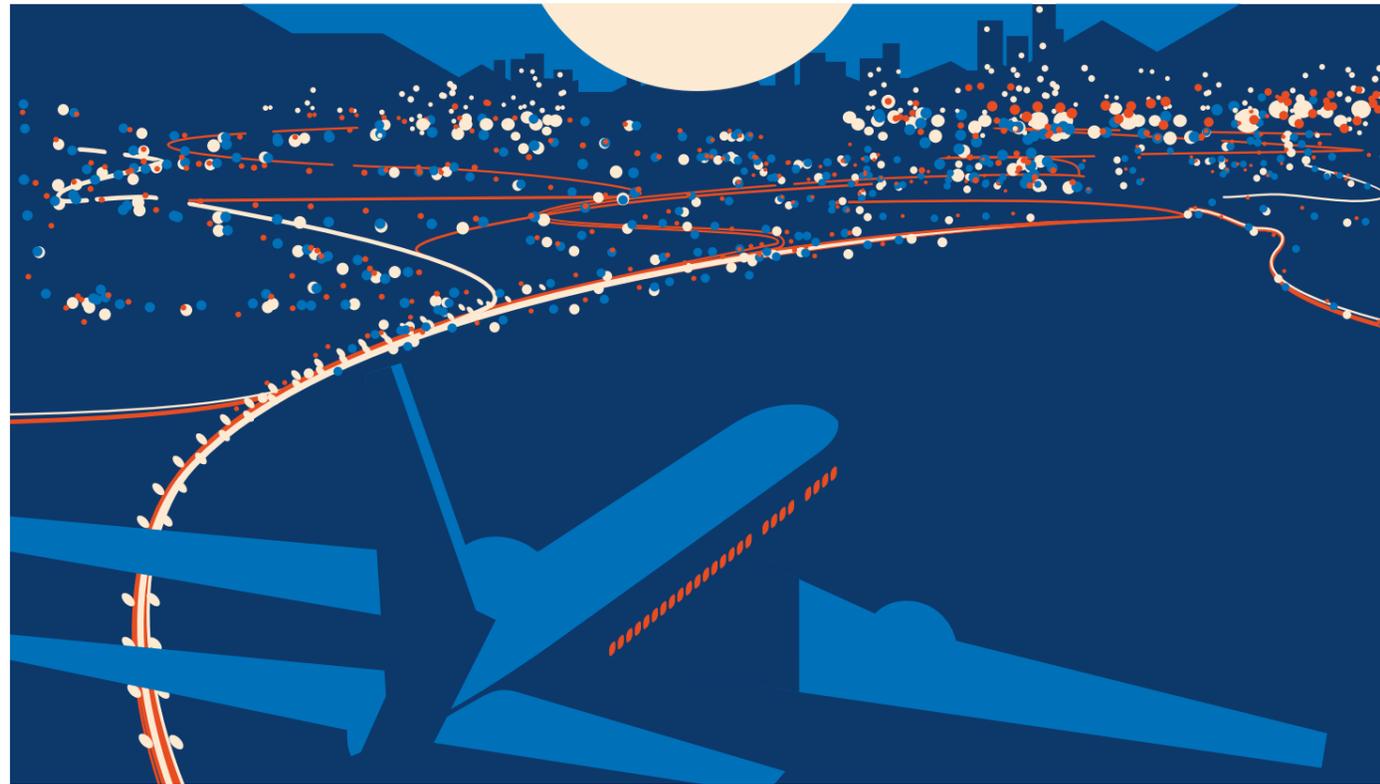
16. Divert to PLB

23:08 UTC aircraft a XXX airport - YYY airport take off rwy10. 23:10 UTC PIC request final level180. 23:22 UTC after passing f150 request RTB due to landing gear problem. 23:30 UTC tower info condition aircraft to Airport Rescue and Fire Fighting. 23:49 utc position on 5 nm pic state no need asst on arrival. 23:51 UTC aircraft a normal landing RWY 10 vacate rwy via s4. 23:52 UTC RWY inspection by Airport Rescue and Fire Fighting. 23:54

utc open normal after declare RWY clear and safe.23:56 UTC aircraft a block on stand17.

Thank you for your report. It is important for a pilot to concentrate on the implementation of emergency procedure. It is also important for an ATC to assist for emergency situation as well as for an airport operator to inspect the runway and taxiway for emergency landing. This case shows a good coordination among pilot, ATC and airport operator for safety purpose.

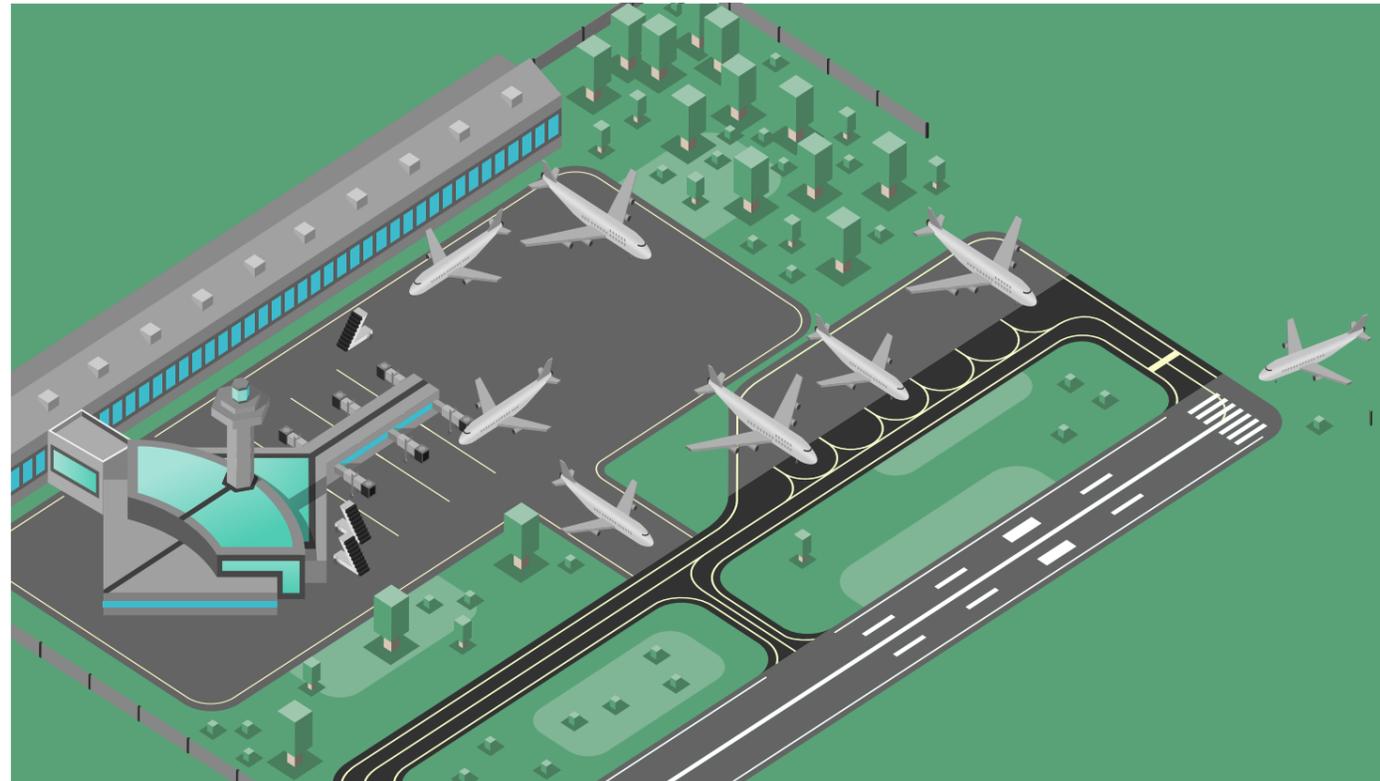
17. PAPI Light Not Accurate

During approach at runway when night regency training, the PIC looked on the papi light not accurate indicated

It is important for aviation personnel to report the airport lighting condition to the airport operator if they found any abnormal condition. Based on that, the airport operator take immidiate action to inspect the condition and conduct mitigation.

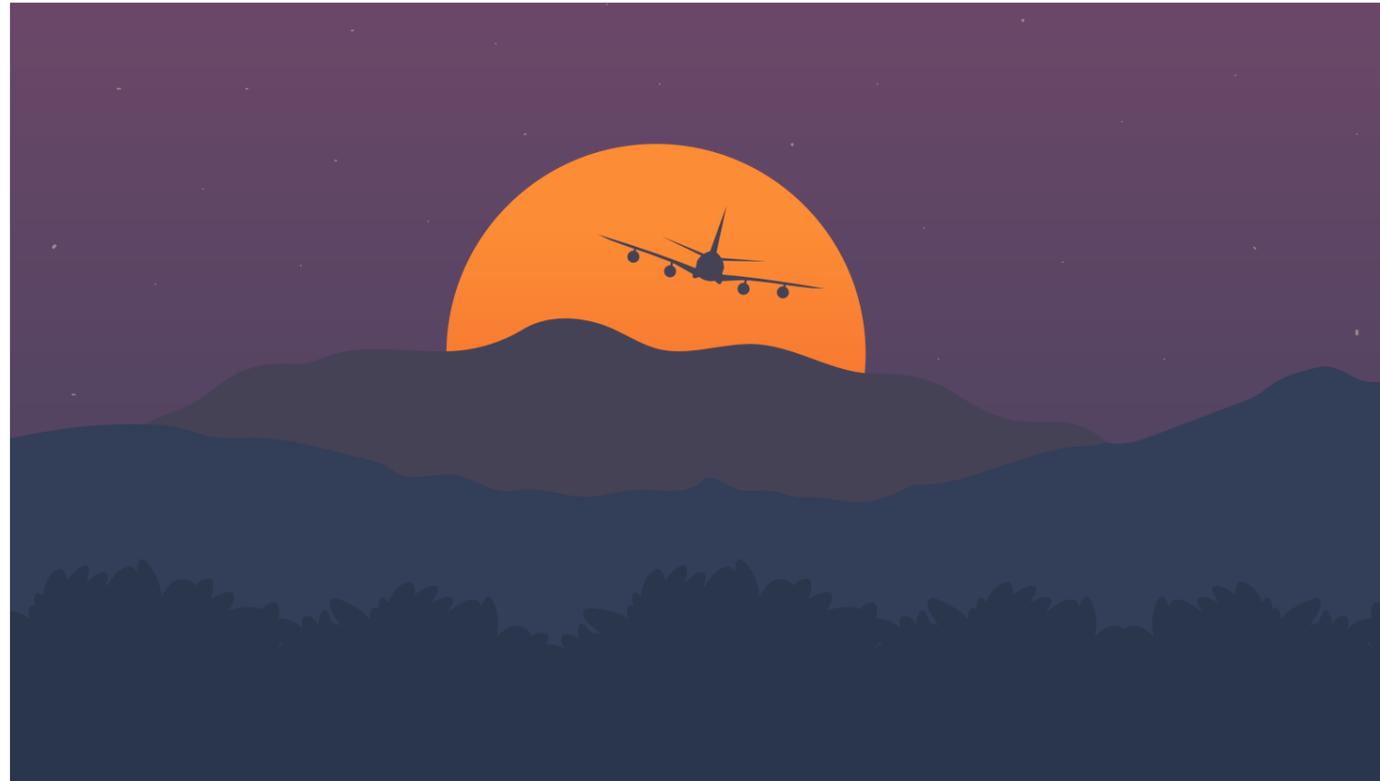
18. Abrupt Interception of ILS

An aircraft has cleared descent to 2500 for ILS Approach Runway 24. At 3000ft about 4 miles to AL arm APP. FMA changed LOC* and G/S* but the Glide Slope still 2 dot above and aircraft initially bank to the left and then bank 30 degrees turn right to Heading 320 to intercept localizer. Suddenly the power increased and the aircraft start climbing. PF

pulled heading knob and arm loc to intercept loc and did the interception GS from above procedure. Established GS and LOC about 2300ft, continue approach and landed safely.

Thank you for your report. It is important for aviation personnel to report any ILS abruption to the air navigation service provider (ANSP). Based on that, the ANSP may take action to inspect the condition and conduct mitigation.
