MINISTRY OF TRANSPORTATION
DIRECTORATE GENERAL OF CIVIL AVIATION

RESPONSE

BULLETIN

ISSUE 02 | JULY 2019

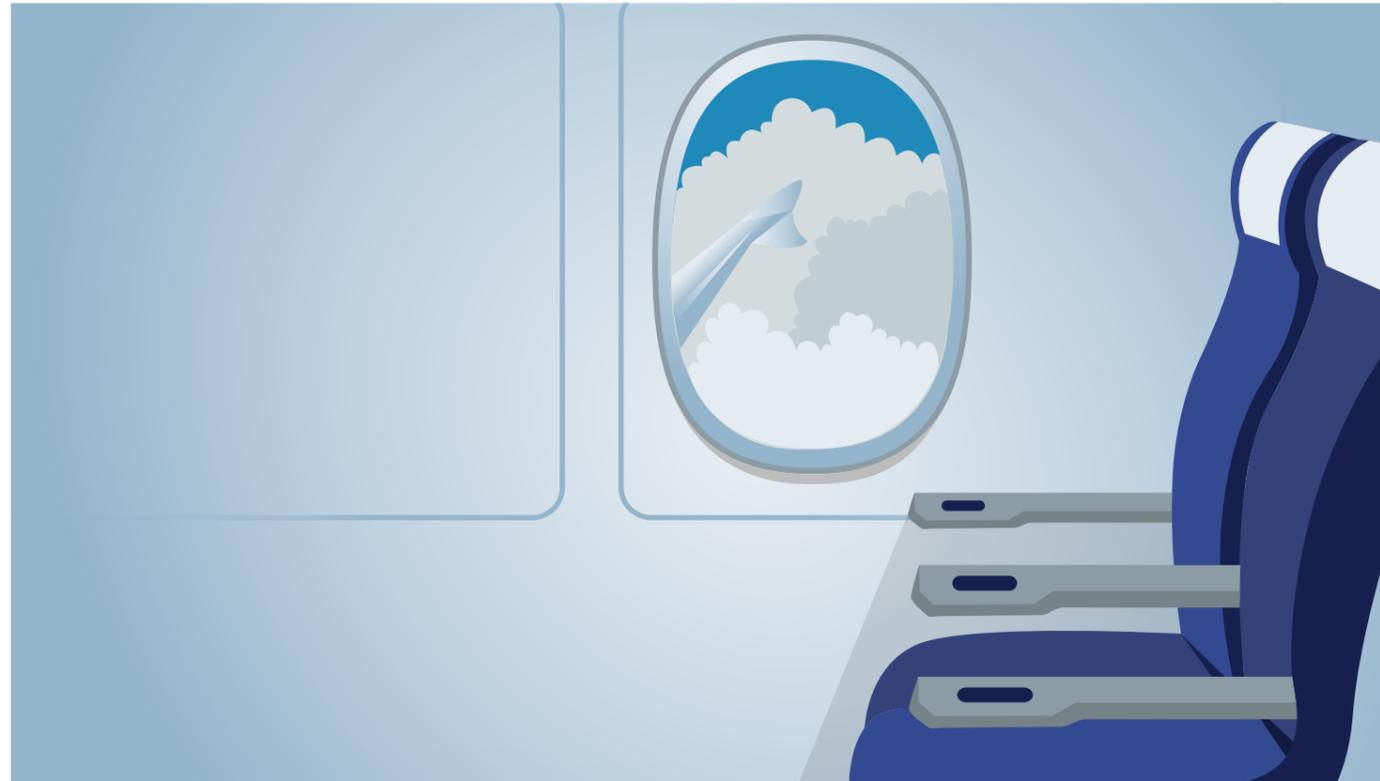
19. Passenger Baggage Trip Repeated when another passenger opens Luggage Bin

I hereby inform the chronology of the incident that happened to one of our passengers. When disembarked when fast seat belts were off and the flight attendant was doing a cross check on a slide bar, one of the passengers opened the luggage bins in the front and there was a bag that fell and hit the passenger sitting right at number 3C. Then the passenger immediately asked about the victim's condition

and we offered to be examined at the airport clinic Juanda in Surabaya during the transit but the victim did not want to and said that he was fine. When we returned to boarding in Surabaya, we confirmed the condition of the passengers and we offered to put on a first aid kit but the father confirmed that it was not necessary and only wanted the crew to make a trip report to remind us to be more careful when storing items and opening luggage bins.

It is necessary for flight attendant to ensure that all luggage are properly stored and to remind the passengers to be careful when opening the luggage compartment.

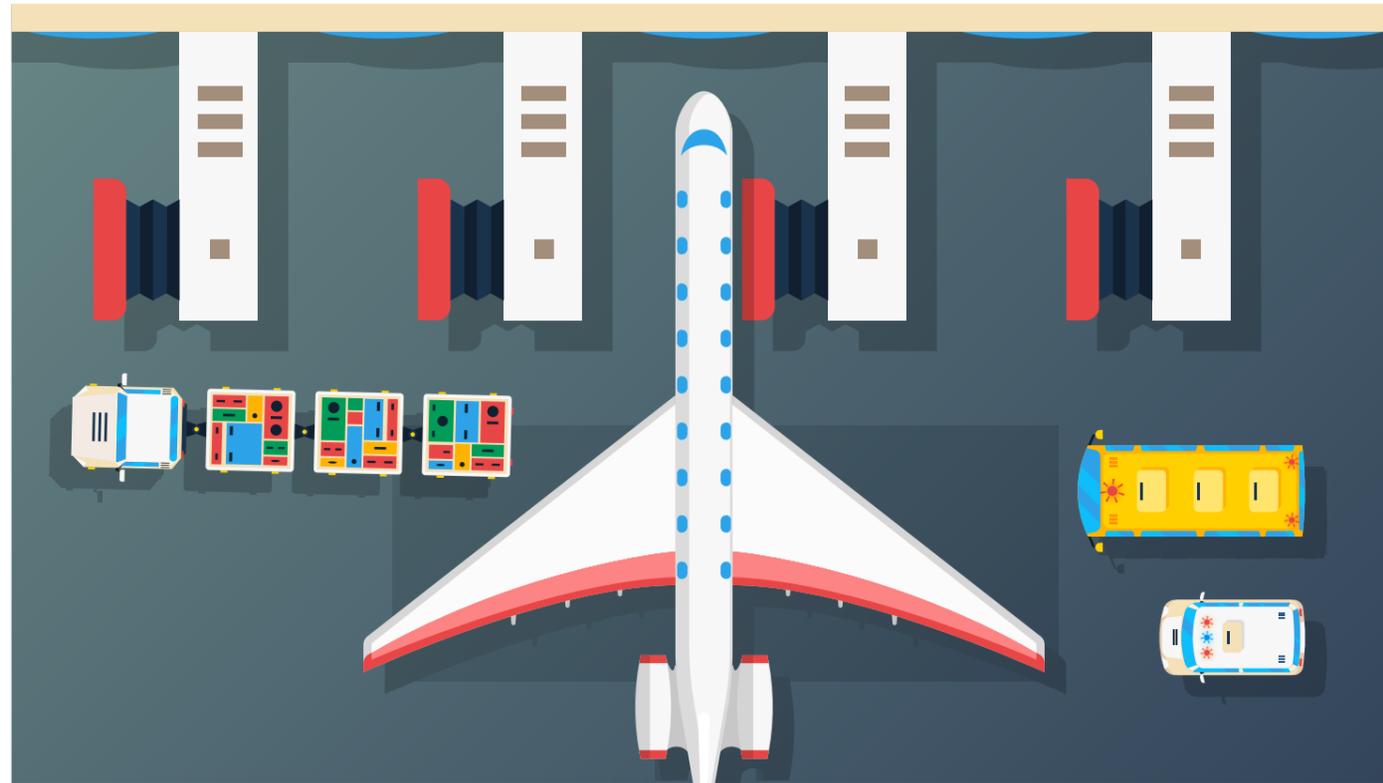
20. The surface for cart storage at airport not yet asphalt

Based on report from an aircraft representative, the surface for cart storage at an airport was not asphalt yet. The condition will make potential FOD like dust & sand will exist at the apron.

It is important for aviation personnel to report the apron surface condition to the airport operator if they found any abnormal condition. Based on that, the airport operator take immediate action to inspect the condition and conduct mitigation.

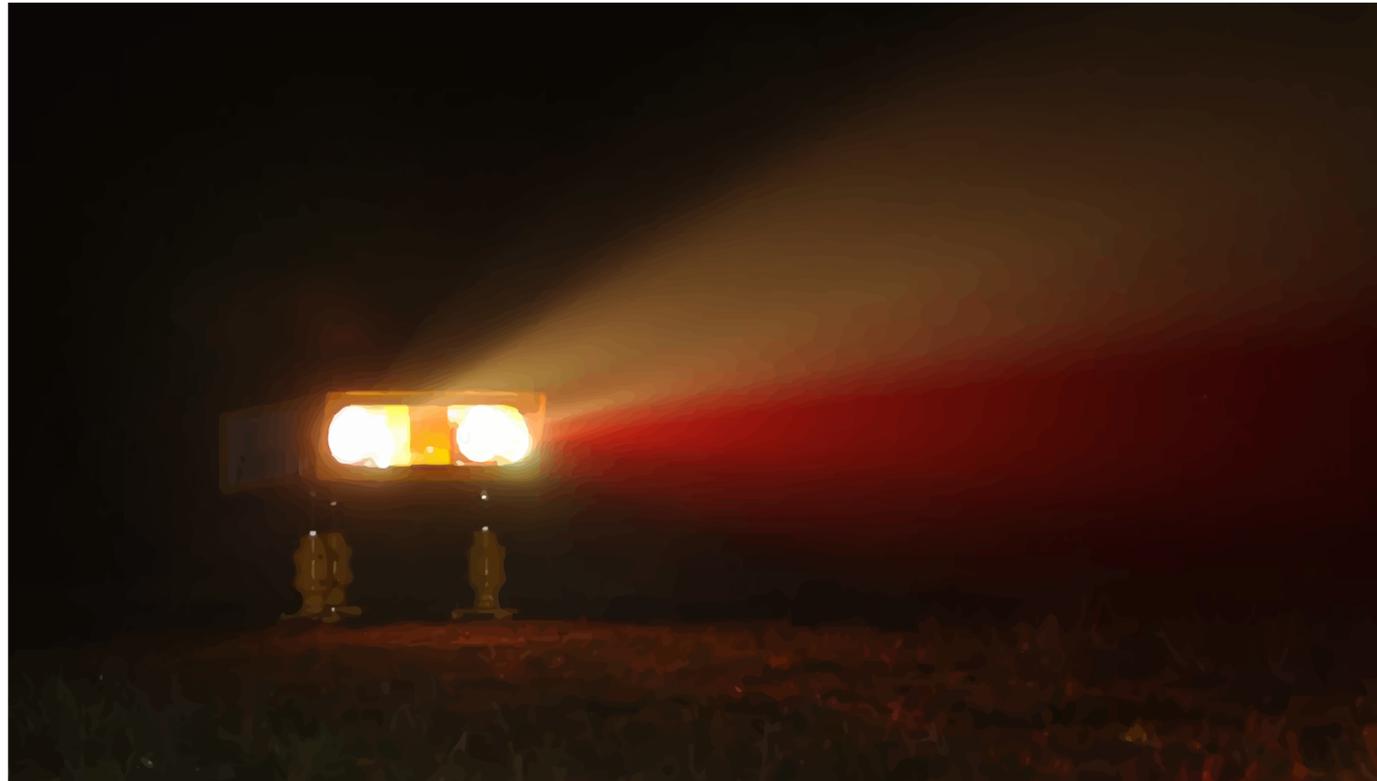
22. PAPI Light Issue

PAPI light issue during conducting ILS approach runway XXX PAPI light showing 3 red 1 white eventhough the aircraft consistently following glide slope guidance.

It is important for aviation personnel to report the runway lighting condition to the airport operator directly if they found any abnormal condition. Based on that, the airport operator take immediate action to fix the problem and to conduct inspection more intensively.

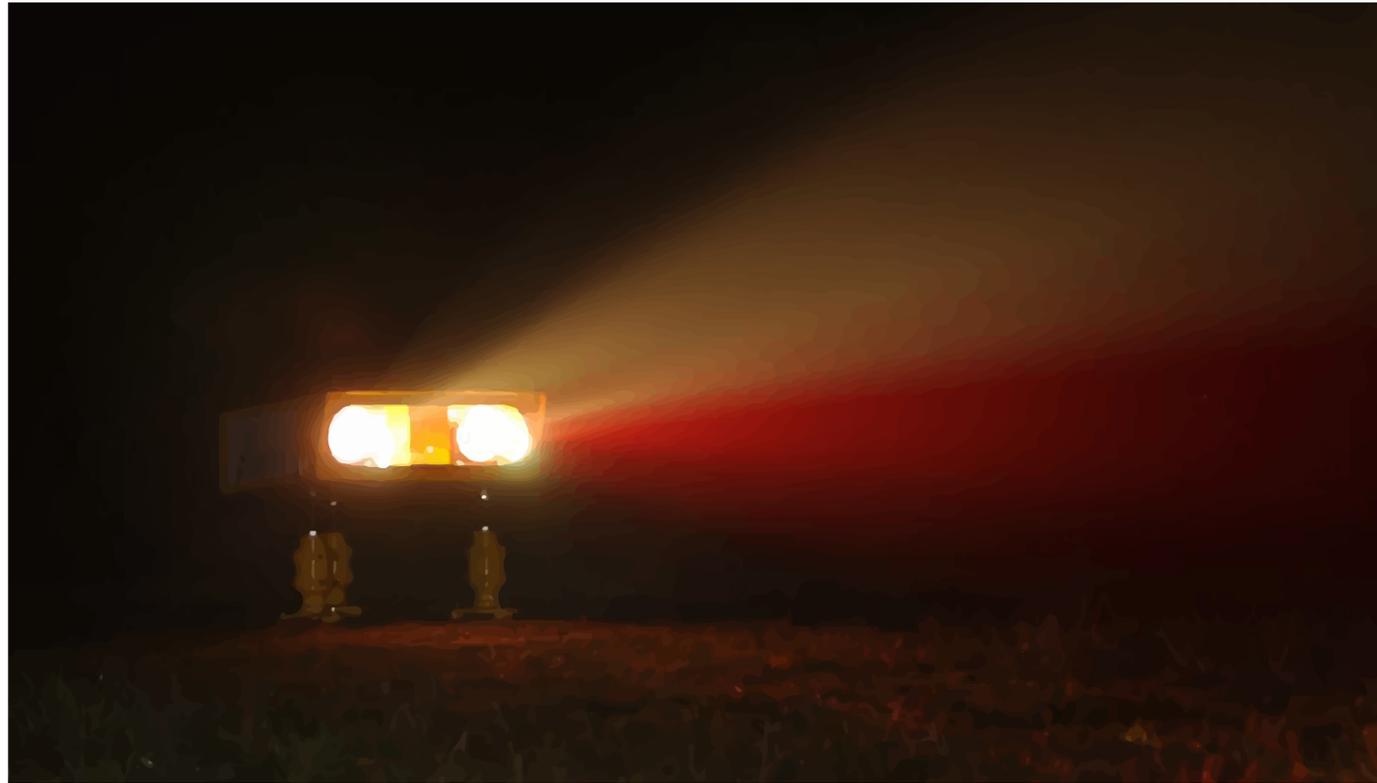
23. PAPI Lights are hard to distinguish

Following the VOR DME RWY 13 with AP1 engaged has the PAPI lights 3 whites and 1 red (both pilot confirm and agree) at around 1300ft, PIC disconnect the AP and adjust the profile to try to capture PAPI profile. At first time the sink rate was VS -1300ft and with a strong tailwind, later on it became 4 whites, PF try to put V/S 1000 fpm, and was unable to recapture correct PAPI profile. PIC decided the make Missed

Approach at below minimum (with FO calling out 4 whites sighted visually but CAPT called out 3 whites) and capt decided to Go Around, Missed approach path to XXX point and second approach VOR DME rwy 13 was uneventful and landed safely. The PAPI lights are hard to distinguish between white vs red colors.

It is important for aviation personnel to report the airport lighting condition to the airport operator if they found any abnormal condition. Based on that, the airport operator take immediate action to inspect the condition and conduct mitigation.

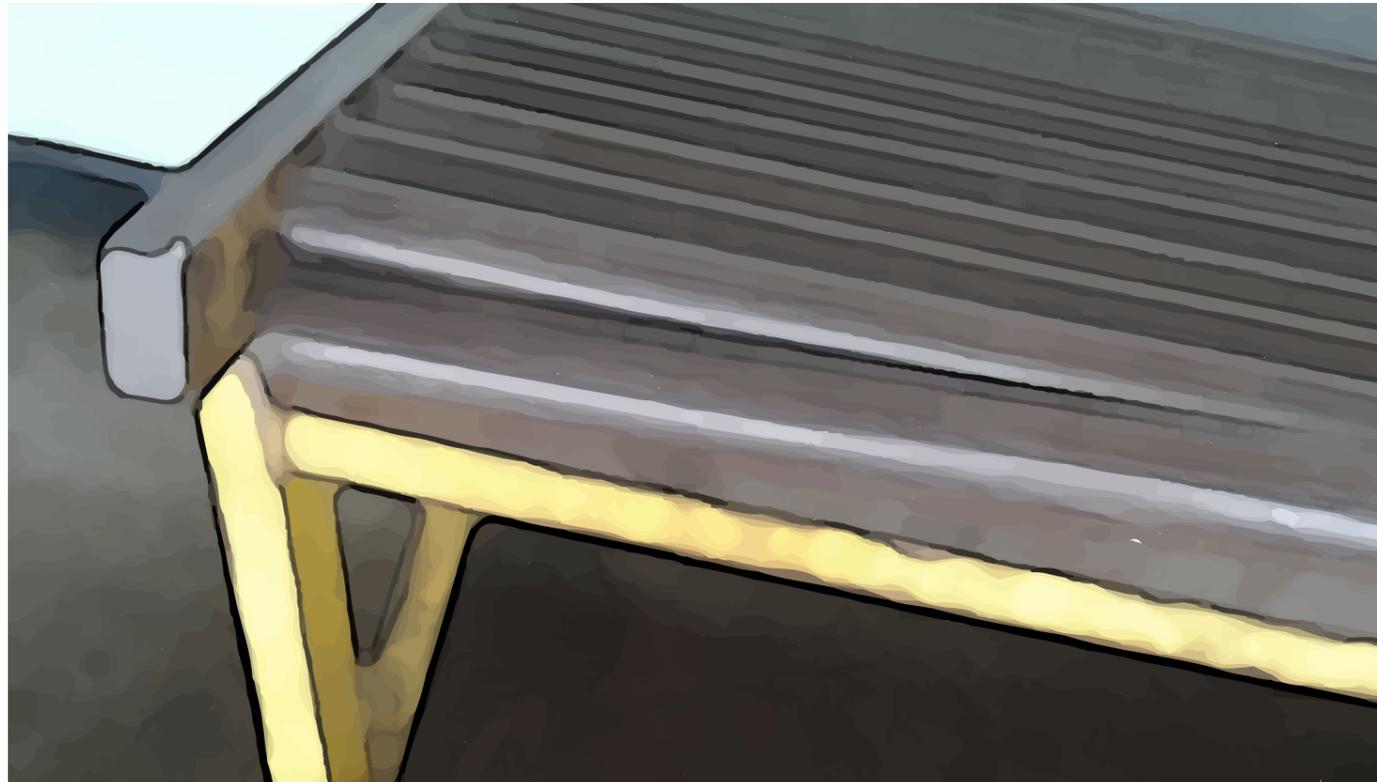
24. Rolling area breakdown 1b is apart / detached

A reporter found the rolling breakdown area in a loose state / apart from the conveyor 1. In case it fell down during the unloading process, it may cause injury to the duty staff.

It is important for aviation personnel to make a report directly to the airport operator if they found any abnormal condition. Based on that, the airport operator take immediate action to fix the problem and to conduct inspection more intensively.

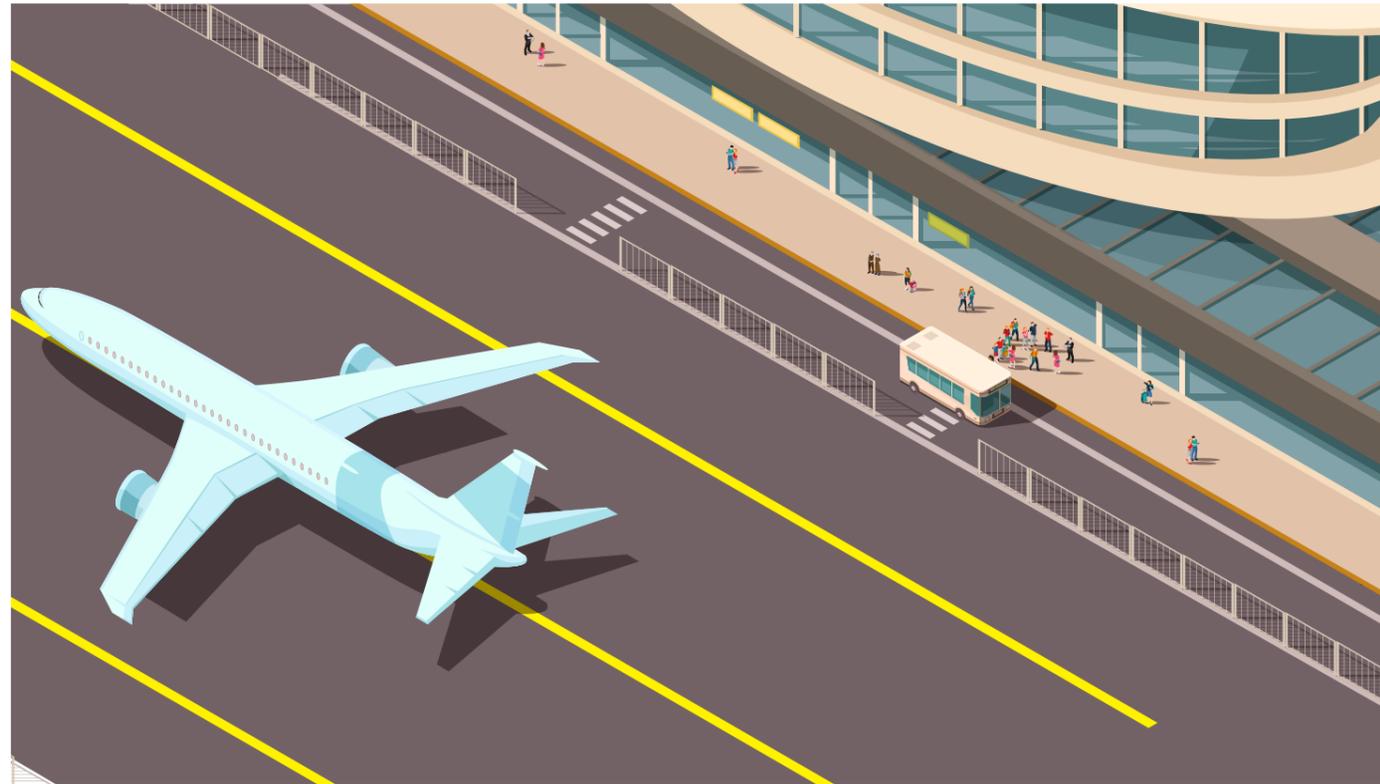
25. Taxiway Surface Issue

On taxiway NP2, holding short of holding point “N1”(about 50m), a/c was unable to continue taxi (when we cleared for line up RWY 10) even when thrust increase set at 40% N1

It is important for aviation personnel to report the runway condition to the airport operator if they found any abnormal condition. Based on that, it is essential for the airport operator to increase the awareness when receiving these kind of reports and take immediate action to fix the problem.

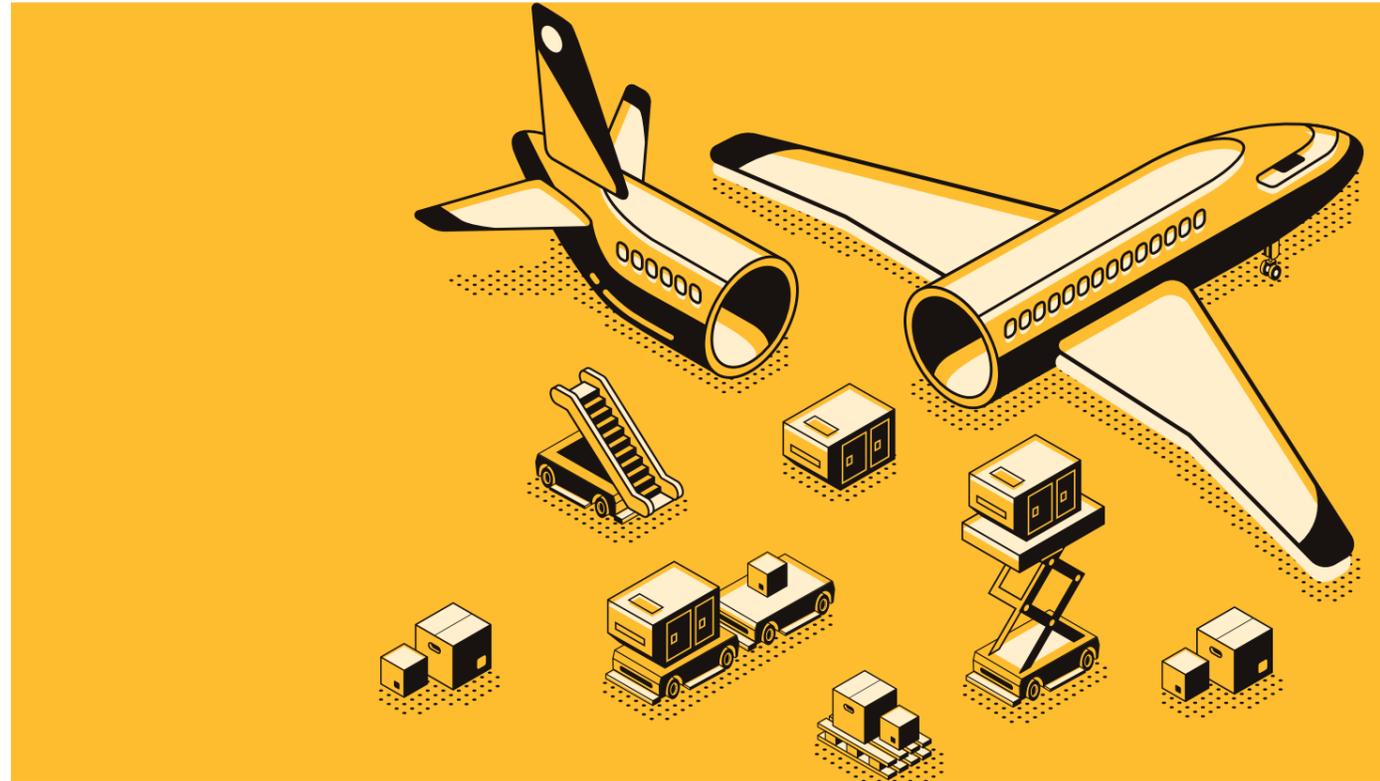
26. Baggage left behind in cargo compartment

During pre-flight, a personnel found baggage in right forward cargo compartment. After asking the FOO and cargo loader, they conclude that the baggage was left behind. It should be unloaded on last flight yesterday.

Thank you for reporting. In order to ensure the aircraft weight accuracy before a flight, it is necessary for the ground handling to check whether all luggages already unloaded after or before a flight.

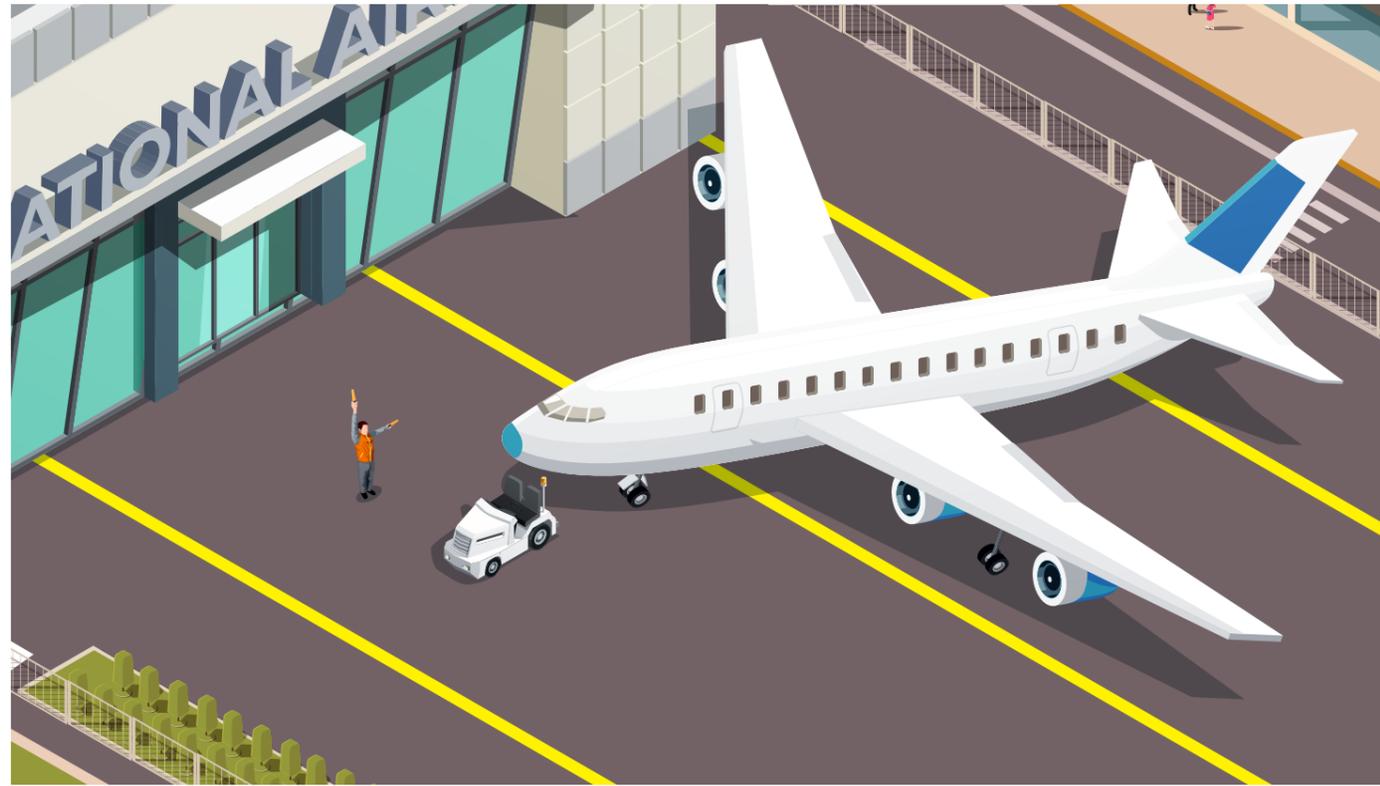
27. Tow Tractor couldn't push the aircraft during push back start

Our flight on Sunday 29th Oct 2018, ETD 23:45lt (16:45z) as info by FOO. Dispatch briefing and boarding process was normal. We Closed the door at 23:45 and request for push back and start from park B8 XXX Airport. After we got clearance from tower, PIC made communication with ground crew for start push back the aircraft. At this time the aircraft couldn't push back, the

ground crew tell us to check parking brake and they also check all wheel chock and brake valve. everything was normal condition (parking brake, brake valve and no chock). The YYY tow tractor try to push the aircraft for second time but the aircraft couldn't move. then the Engineer try to change tow tractor with our Tractor (ZZZ's tractor). on 00:15 lt (17:15z) the aircraft push back with ZZZ's tractor. After complete push back we started the engines and taxi out with normal condition.

In order to keep the vehicle in good condition, it is necessary for the ground handling operator to conduct proper maintenance to any vehicle for handling an aircraft and check the condition before starting the work.

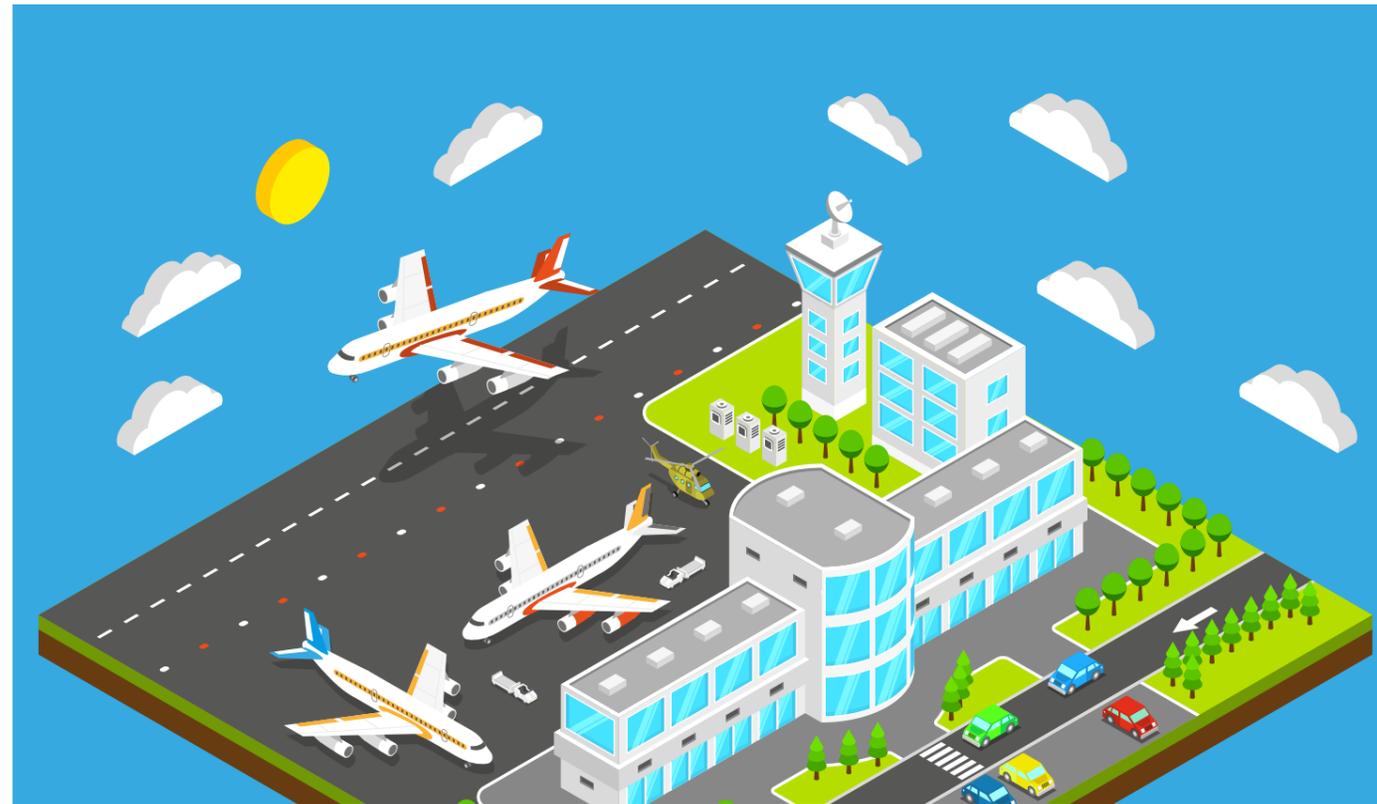
28. Issue of runway, taxiway, and apron

We would like to report regarding marking on runway, taxiway, and apron

1. No centerline marking on runway XXX due to new runway overlay.
2. When taxi in on NP1 to join NC4 to apron G, there was no taxiway edge light and difficult to find the correct taxiway centerline.
3. Parking stand F31 has sharp turn to enter the stand from

taxiway NCY. Its line was blurry like its been erased and has paralel line with a better distinct line, cause ambiguity in determining which one is correct. Kindly assist us to deliver this information to airport. Thank you.

It is very important for a pilot to inform any issue in the moving area of airport directly to the airport operator. Also, in order to resolve the matter, we recommend that it is essential for the airport operator to confirm to the reporter if necessary and take appropriate action immediately

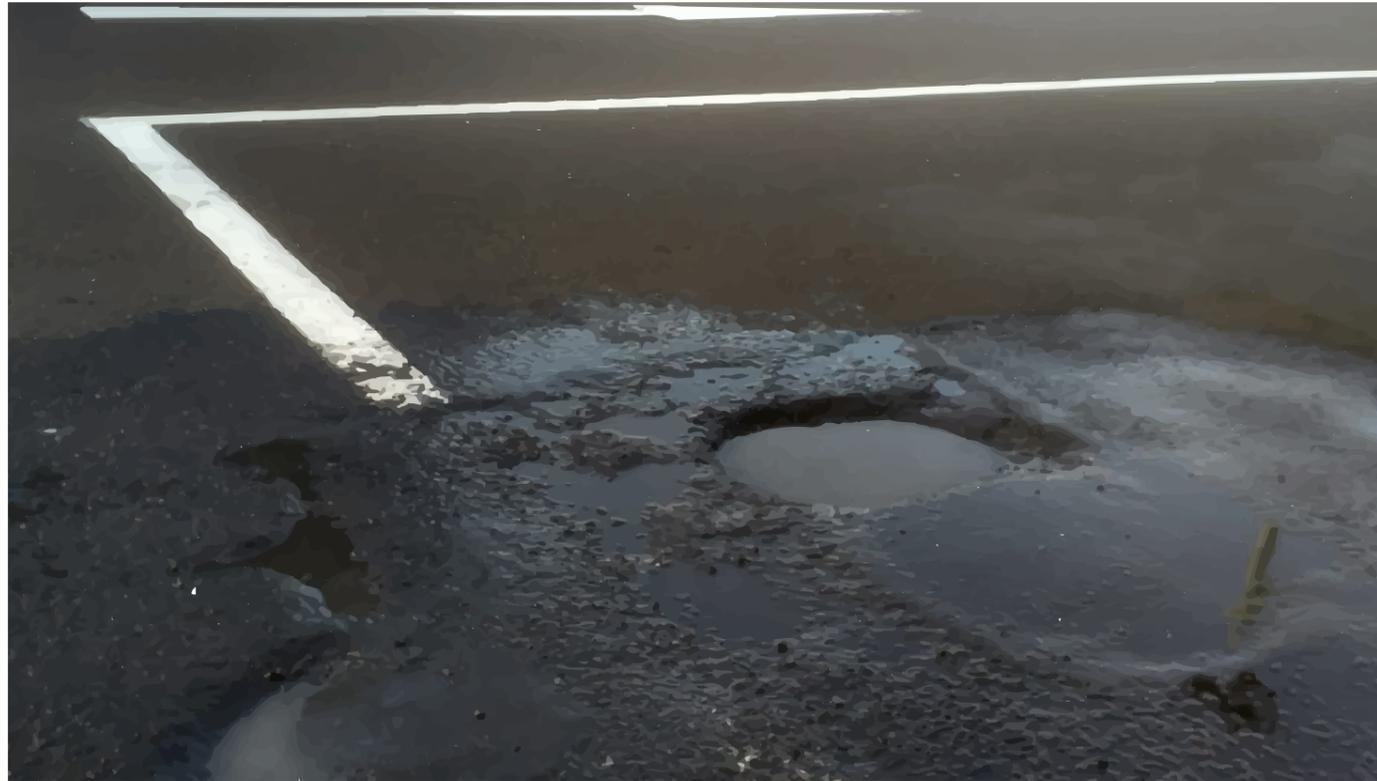
29. Found a hollow in the service road near the parking lot

I found a hollow in the service road near the parking lot. The hole can cause damage to the ground equipment if it is hit / passed through the hole.

It is important for aviation personnel to inform the airside area condition to the airport operator directly when they found any abnormal condition. Based on that, the airport operator take immediate action to fix the problem and to conduct inspection more

intensively.

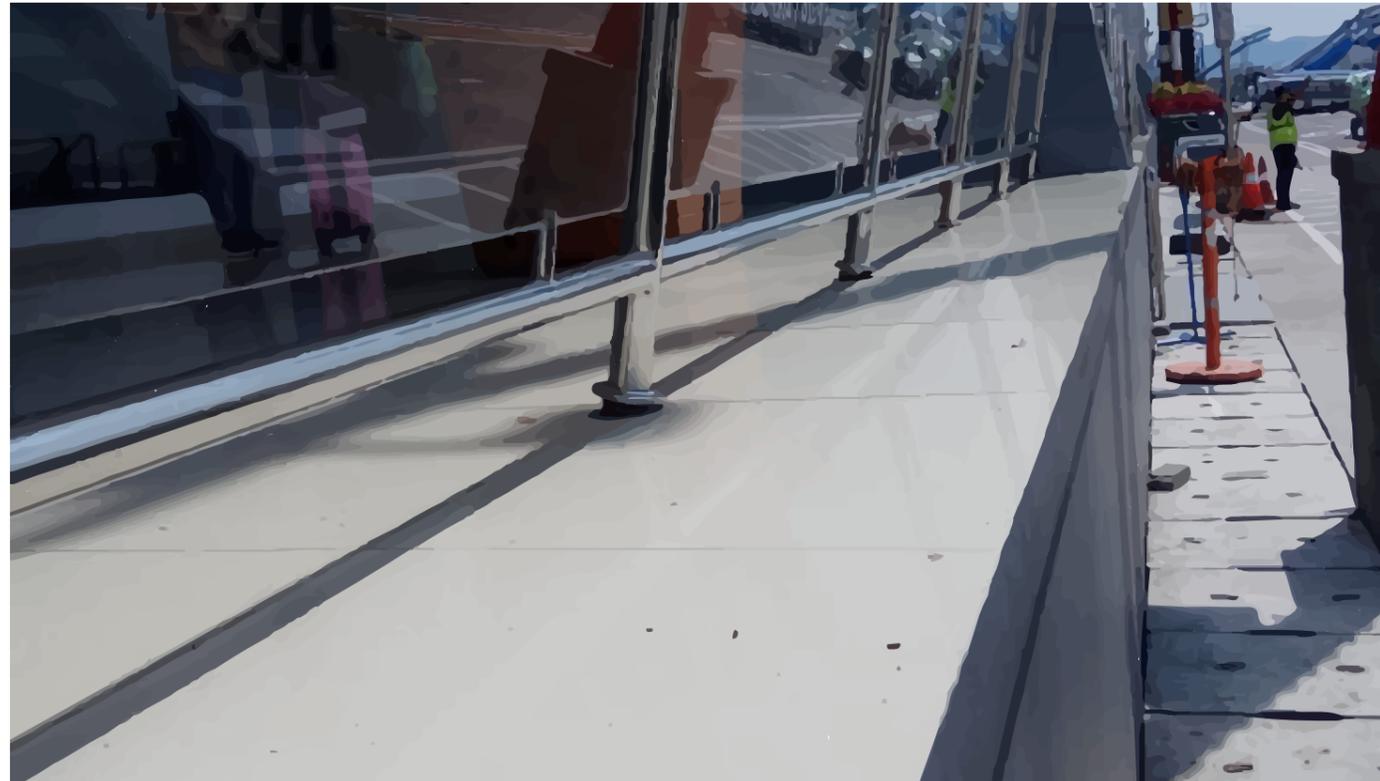
30. Limiting Roads Oblique Looks Not Strong

The sloping road divider looks not strong, it can be dangerous if the passenger holds it when boarding at the airport

It is important for aviation personnel to report the airport facilities to the airport operator directly when they found any abnormal condition. Based on that, the airport operator take immediate action to fix the problem and to conduct inspection more intensively.

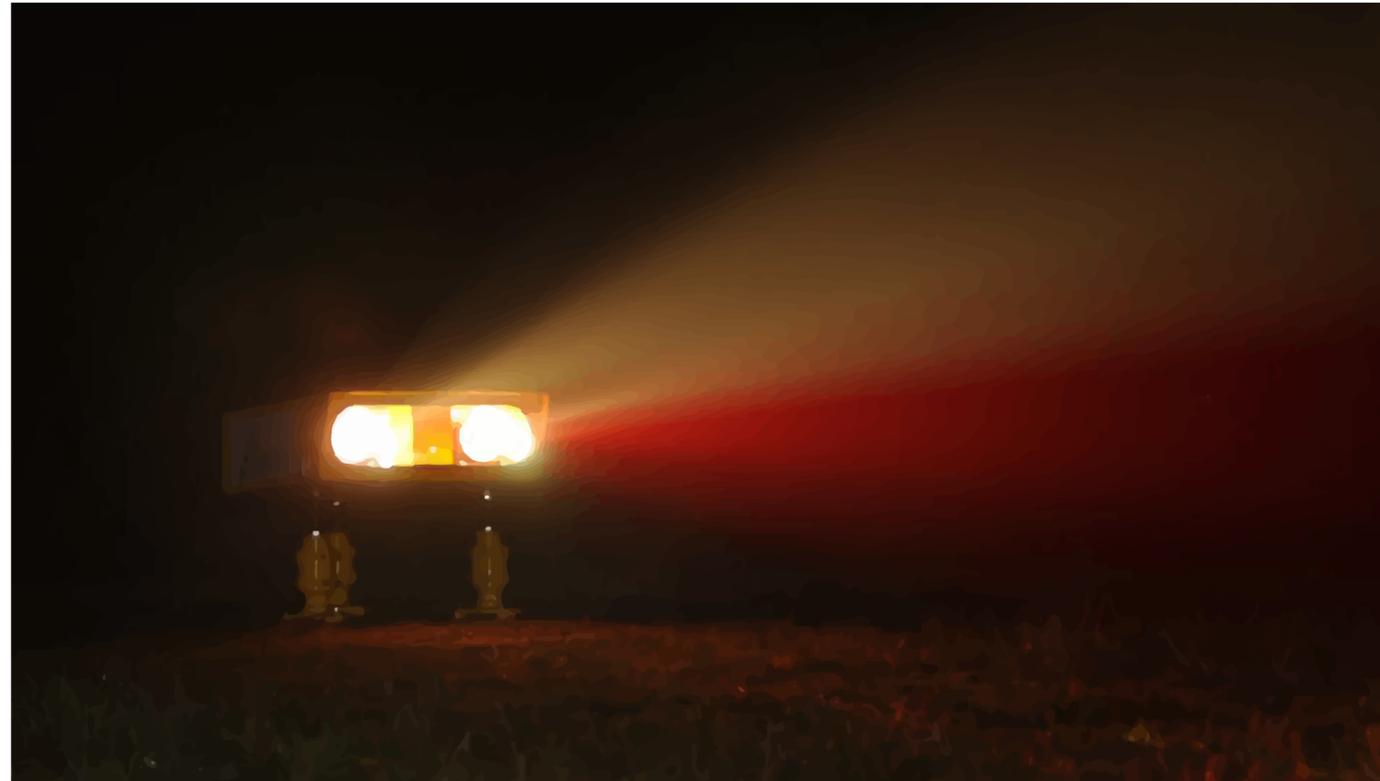
31. No PAPI Light on runway

It is essential that the airport operator take immediate action and mitigation

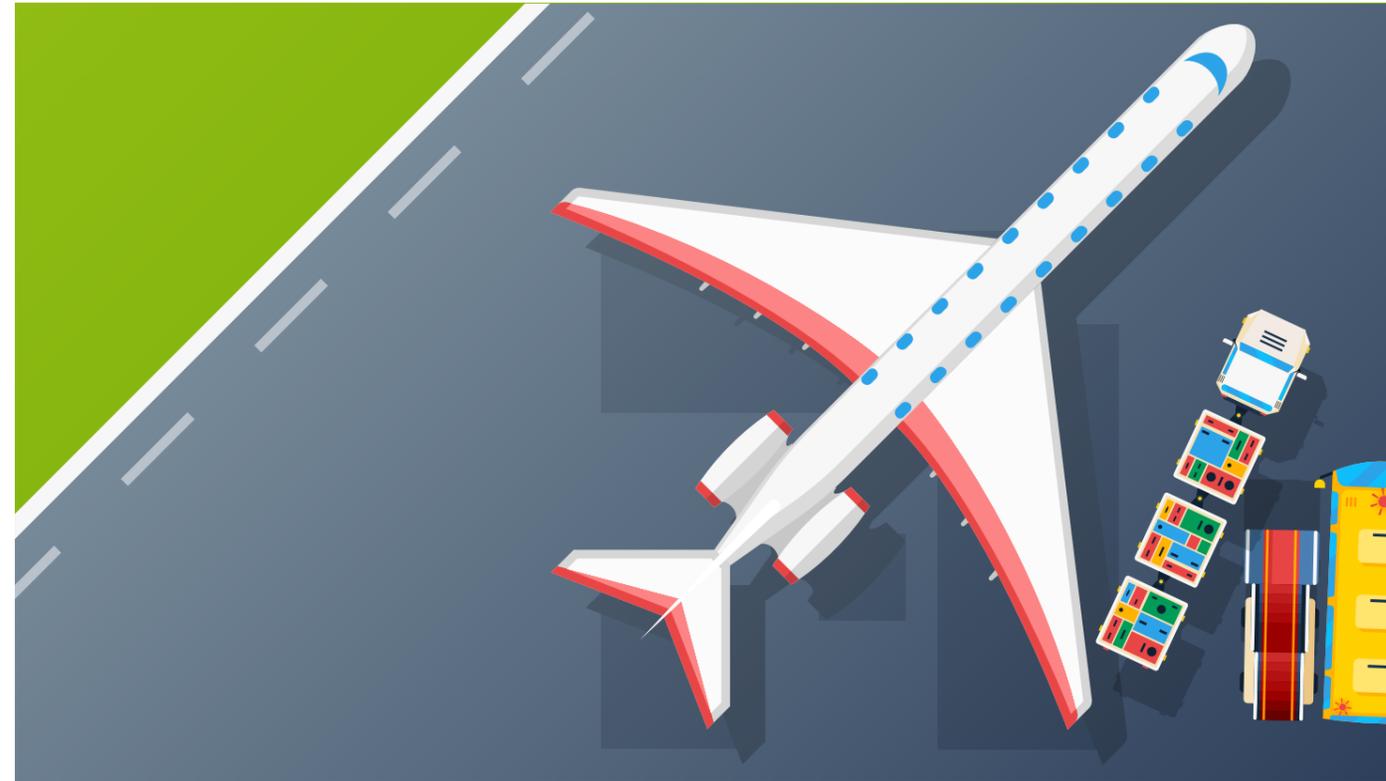
32 Passenger Stairs Cannot Be Installed Because Vehicles Are Obstructed

Aircraft park at gate XXX airport but the stair can not be attached due to blocked by vehicle as on the attachement picture

It is important for aviation personnel to obey the regulation of airside parking area. In this case, the reporter should directly report to the airport operator. Based on that, the airport operator take immediate action to fix the problem. It is also essential for the airport operator to ensure

the surveillance is conducted properly in accordance with related procedure.
